City of Encinitas

4.4.17 Assessment of Ficus Tree At 364 Second Street (Side-2)

John Ugrob
Utility & Maintenance Supervisor
Street/ NPDES Division
City of Encinitas

APRIL 4, 2017

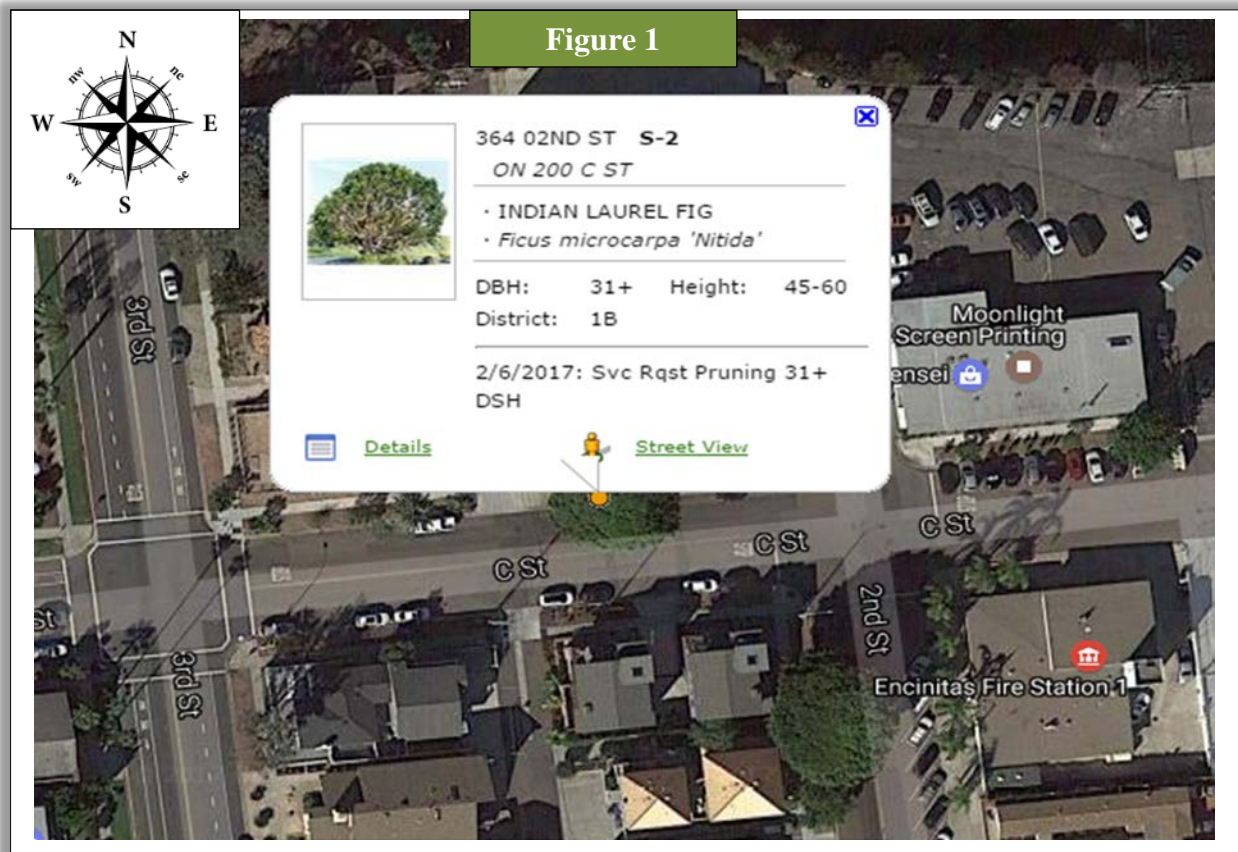
In March of 2017, West Coast Arborists, Inc., (WCA) was contacted by John Ugrob (City of Encinitas) in regard to the assessment of an Indian Laurel Fig tree (*Ficus microcarpa 'nitida'*) located near 200 C Street. In ArborAccess (WCA's tree inventory database), the tree is inventoried a 364 02ND ST S-2 on 200 C ST and had a Facility I.D. # of 4988ETREE (see Figure 1 below).
