City of Encinitas

4.4.17 Assessment of Ficus Tree At 402 Second Street (Front-2)

APRIL 4, 2017

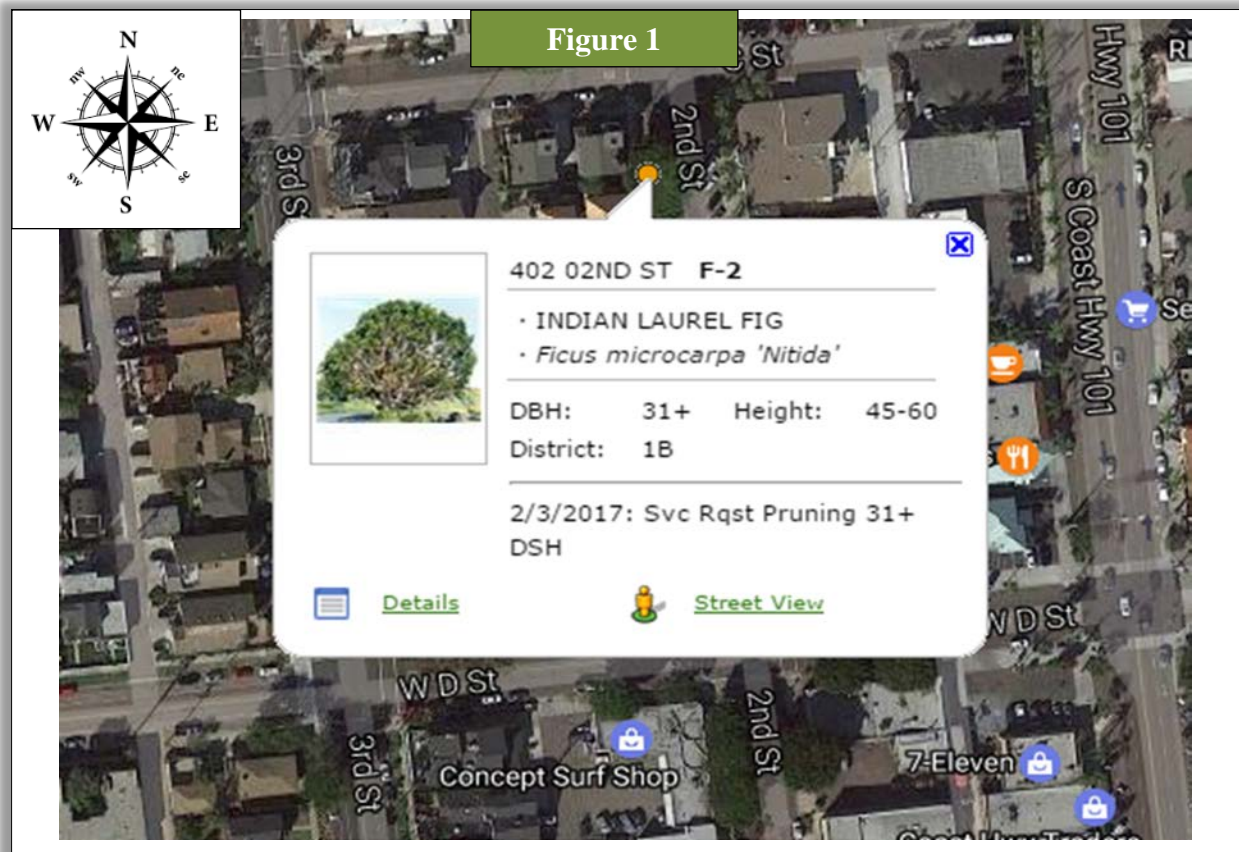
In March of 2017, West Coast Arborists, Inc., (WCA) was contacted by John Ugrob (City of Encinitas) in regard to the assessment of an Indian Laurel Fig tree (*Ficus microcarpa 'nitida'*) located near 402 2nd St. In ArborAccess (WCA's tree inventory database), the tree is inventoried as 402 02ND ST F-2 and has a Facility I.D. # of 5049ETREE (see Figure 1 below).

- The tree was growing in an 8.5 foot wide parkway on the west side of 2nd St. and in front of the 402 address (see Figure 1, as well as Photo #1 in Appendix A).

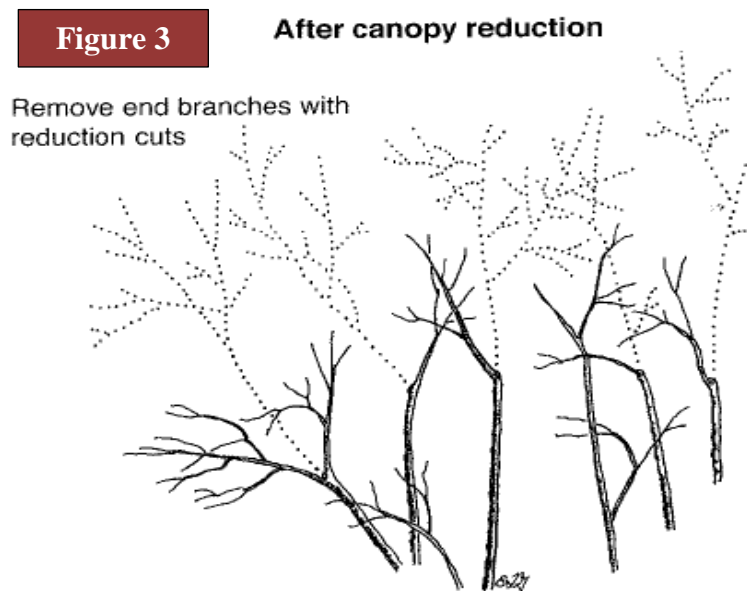
- Shown above is an example of reduction pruning techniques to achieve a canopy reduction. The diagram is from the International Society of Arboriculture “Best Management Practices for Tree Pruning” 2008 publication.
- If there are not suitable laterals meeting the 1/3rd size correlation, pruning other reduction cuts may only be considered under the direction of an ISA Certified Arborist. Some of these reduction pruning cuts will be done to a shoot, branch, or stem that extends nearly as far as the removed parent branch; if this is the case then additional subordination pruning cuts back to a bud or young growth may be acceptable in order to maintain a point of **apical dominance** and to achieve the reduction goal.

1. Remove the tree and replace it with a with a healthy site adequate species.
2. Applying **reduction pruning**, and **removal pruning cut** techniques (not **topping**) to reduce the overall canopy height and spread by about 25% (see Figure 3 and Appendix B). This recommended pruning should be done in compliance to ANSI A300 Arboricultural Standards and will need to be applied over multiple spaced out pruning doses (up to five years) to minimize health impacts on the tree. This is also recommended to allow time for interior growth to further develop and broaden the options for new branches to prune back to. The end outcome should be a reduction of **mechanical stress** from overextended loads. The first pruning dose should address reducing the overextended stem of concern to immediately reduce the trees' overall risk.
