City of Encinitas

3.22.17 Assessment of Ficus Tree At 510 Second Street (Front-1)

MARCH 22, 2017

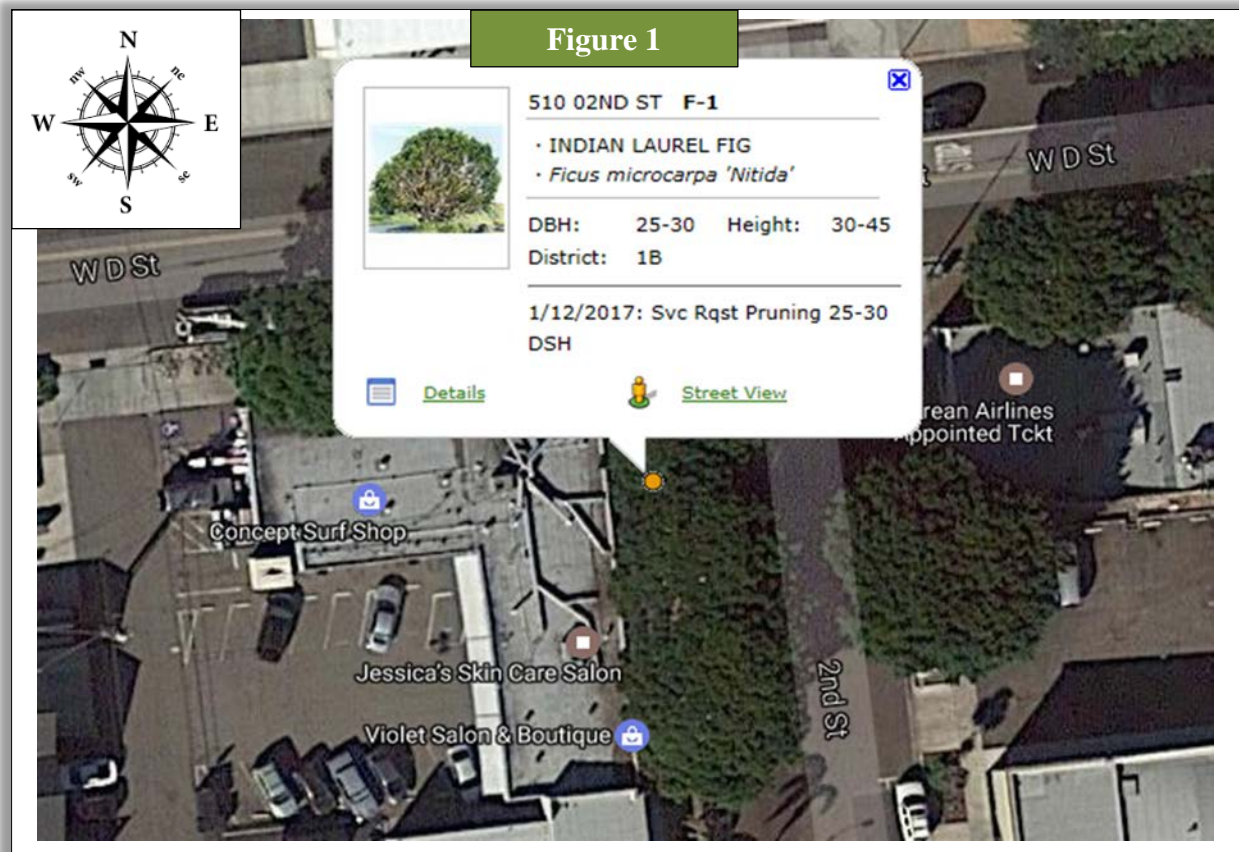
In March of 2017, West Coast Arborists, Inc., (WCA) was contacted by John Ugrob (City of Encinitas) in regard to the assessment of an Indian Laurel Fig tree (*Ficus microcarpa 'nitida'*) located near 510 2nd St. In ArborAccess (WCA's tree inventory database), the tree is inventoried as 510 02ND ST F-1 and had a Facility I.D. # of 5040ETREE (see Figure 1 below).

- The tree was growing in a 7 foot wide tree well on the west side of 2nd St. and in front of the 510 business address (see Figure 1, as well as Photo #1 in Appendix A).

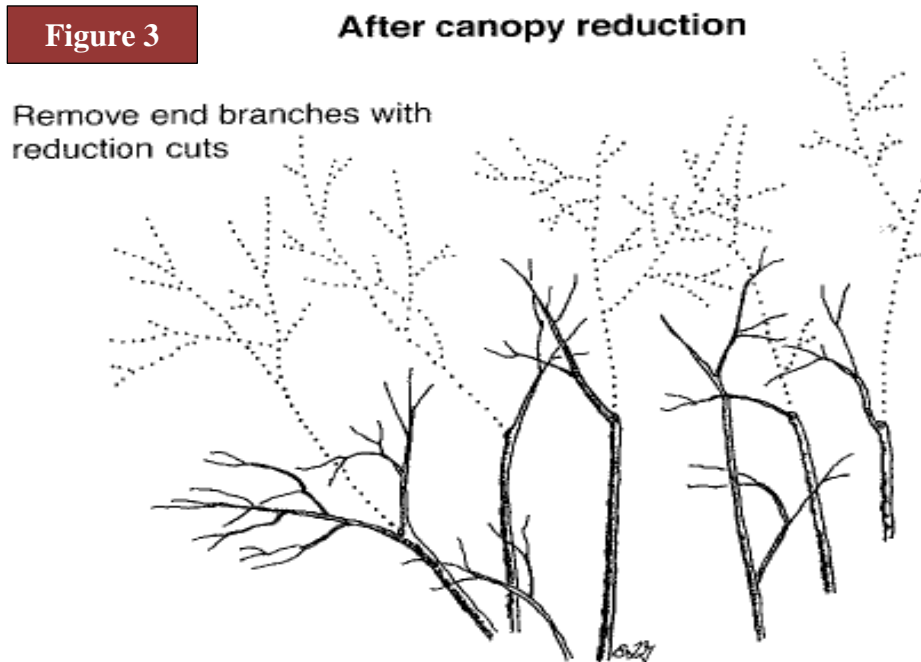
- Shown above is an example of reduction pruning techniques to achieve a canopy reduction. The diagram is from the International Society of Arboriculture “*Best Management Practices for Tree Pruning*” 2008 publication.
- If there are not suitable laterals meeting the 1/3rd size correlation, pruning other reduction cuts may only be considered under the direction of an ISA Certified Arborist. Some of these reduction pruning cuts will be done to a shoot, branch, or stem that extends nearly as far as the removed parent branch; if this is the case then additional subordination pruning cuts back to a bud or young growth may be acceptable in order to maintain a point of **apical dominance** and to achieve the reduction goal.

After analyzing site observations and running them individually through the tree risk assessment matrices (Figure 2), it was concluded that the subject tree is currently presenting an overall low risk and mitigation is not necessary at this time. If the City of Encinitas would like to further decrease the overall associated risks then I recommend reducing or removing the branches pointed out in Appendix A, Photo #3 as well as maintaining the tree near its current height and retaining interior foliage. This should be achieved using pruning techniques which are further explained in Figure 3 below as well as Appendix B .

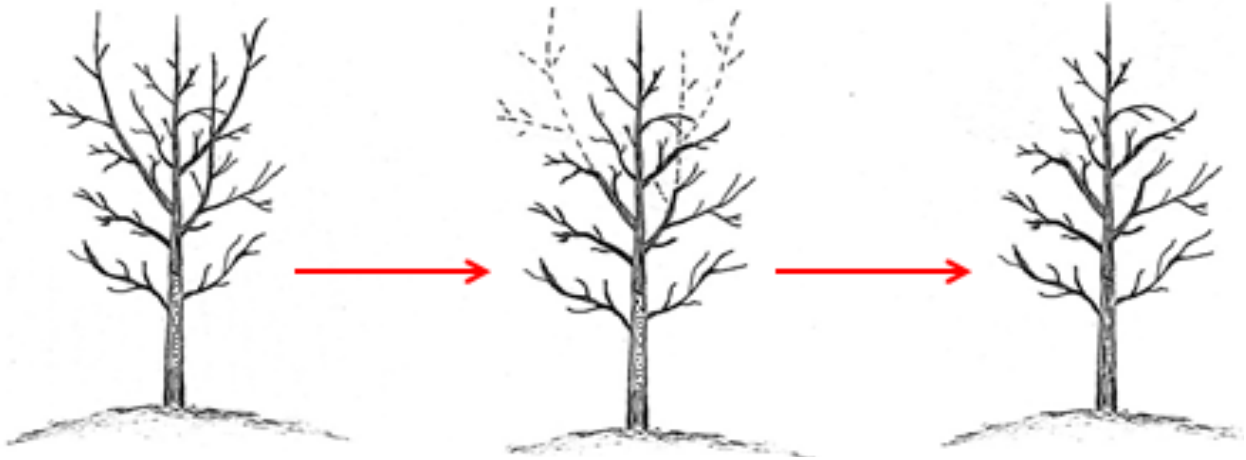
Reduction Pruning Techniques

Reduction pruning: A pruning cut that reduces the length of a branch or stem back to a live lateral branch large enough to assume apical dominance, typically at least 1/3rd the diameter of the cut stem.

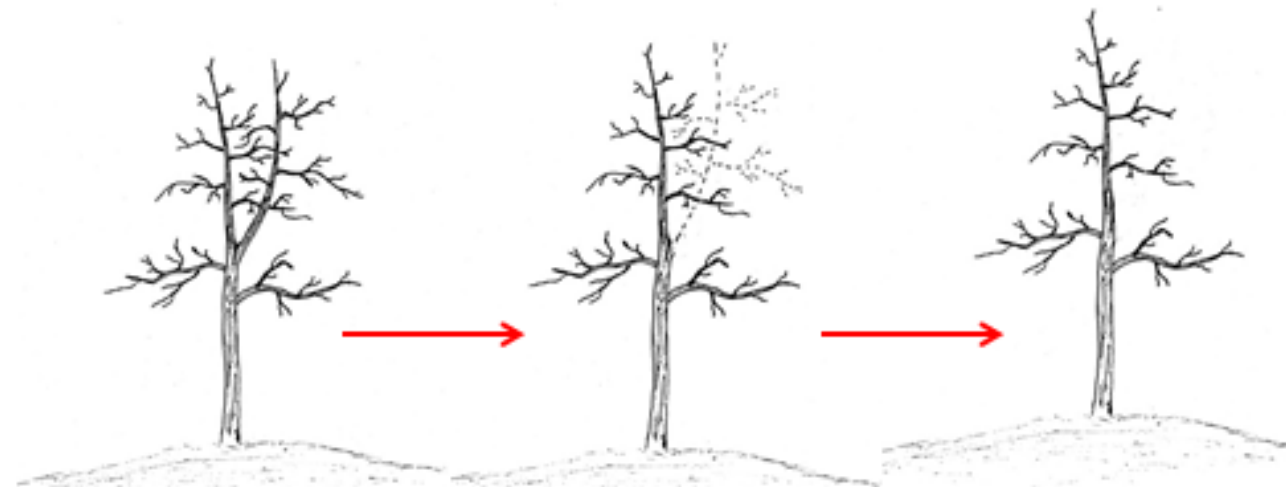
Removal Pruning Cut Techniques

Removal Pruning Cut: A pruning cut that takes off a branch back to the trunk or parent stem to just beyond the branch collar.
