City of Encinitas

3.3.17 Assessment of Ficus Tree Near 510 Second Street

MARCH 3, 2017

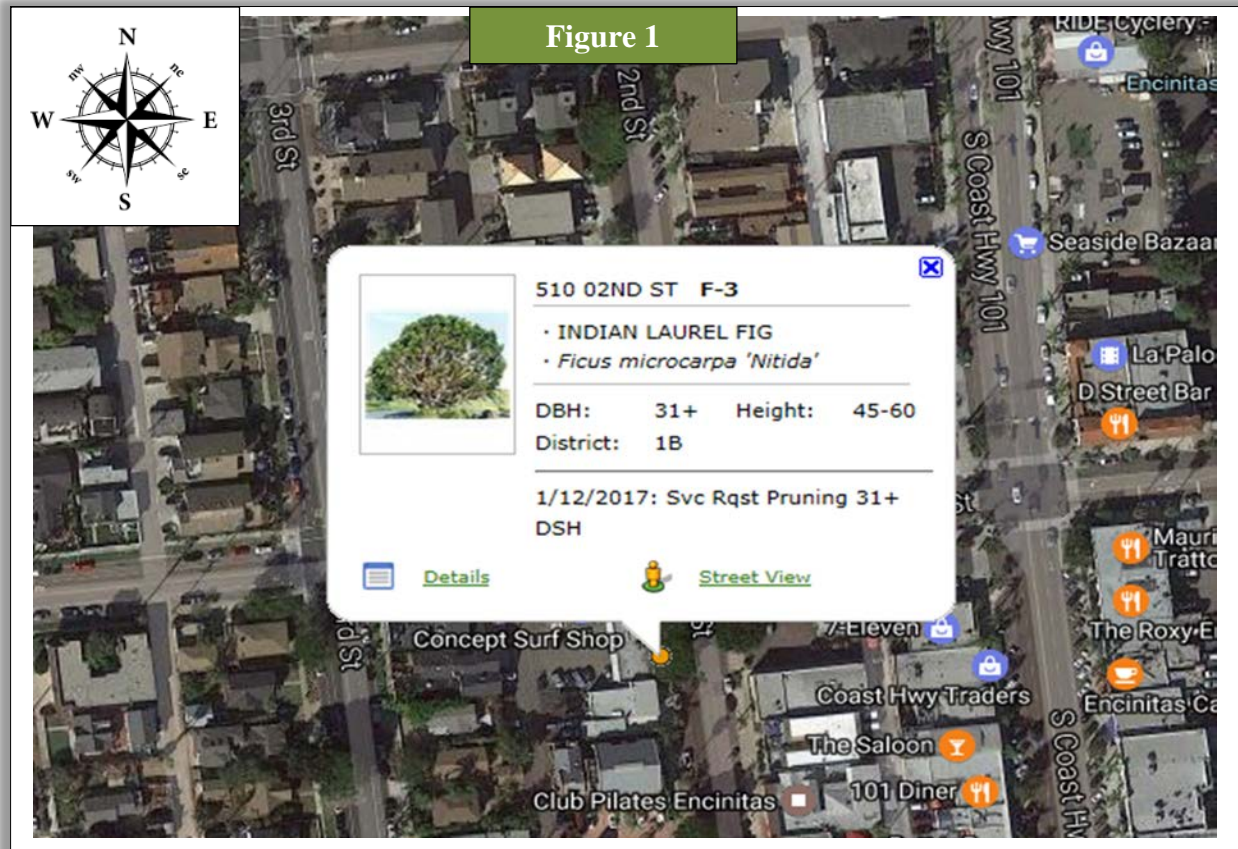
In February of 2017, West Coast Arborists, Inc., (WCA) was contacted by John Ugrob (City of Encinitas) in regard to the assessment of an Indian Laurel Fig tree (*Ficus microcarpa 'nitida'*) located near 510 2nd St. In ArborAccess (WCA's tree inventory database), the tree is inventoried as 510 02ND ST F-3 and had a Facility I.D. # of 5038 (see Figure 1 below).

- The tree was growing in a 7 foot wide tree well on the west side of 2nd St. and in front of the 510 business address (see Figure 1, as well as Photo #1 in Appendix A).

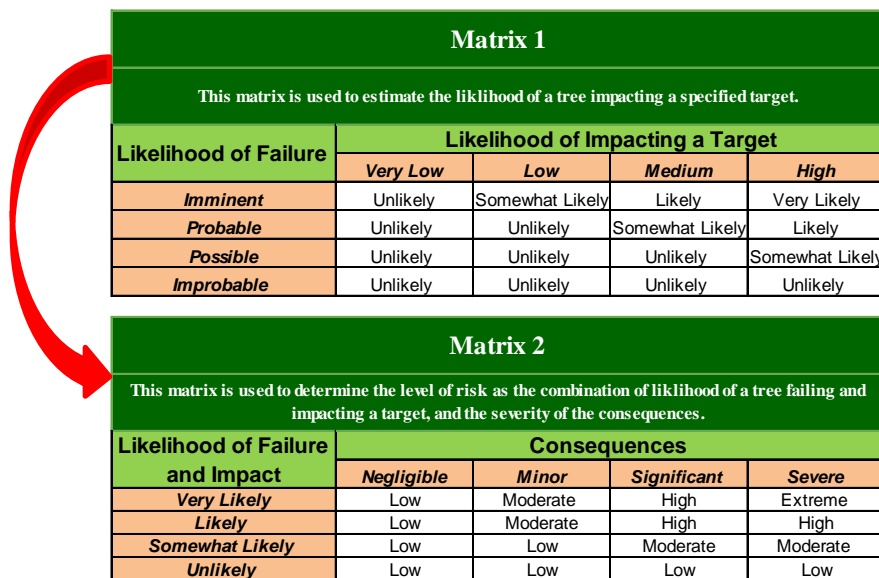
Figure 2

Data collected from the Level 2 Basic Assessment is used to derive a level of risk based on the matrices found in the *ISA Tree Risk Assessment Manual* (see **Figure 2** below). The level of risk determined (low, moderate, high, or extreme) is to be used by risk managers to help in tree management decisions. When assessing risk, the value of targets is taken into consideration in order to categorize the consequences of failure (negligible, minor, significant, or severe). The people who use and frequent the target zone are generally the most important target with buildings, structures, and cars being secondary in importance. Factors such as occupancy rate and protection factors are used to help determine the target that constitutes the highest overall Risk Rating.

After analyzing site observations and running them individually through the tree risk assessment matrices (Figure 2), it was concluded that the subject tree is currently presenting an overall moderate risk. This is likely an unacceptable risk threshold for the City of Encinitas and mitigation pruning should be considered.
