City of Encinitas

3.23.17 Assessment of Ficus Tree At 580 Second Street (Front-1)

Gene Bordson
Certified Arborist # WE-10777A
Qualified Applicator License# 140768
Qualified Tree Risk Assessor

MARCH 23, 2017

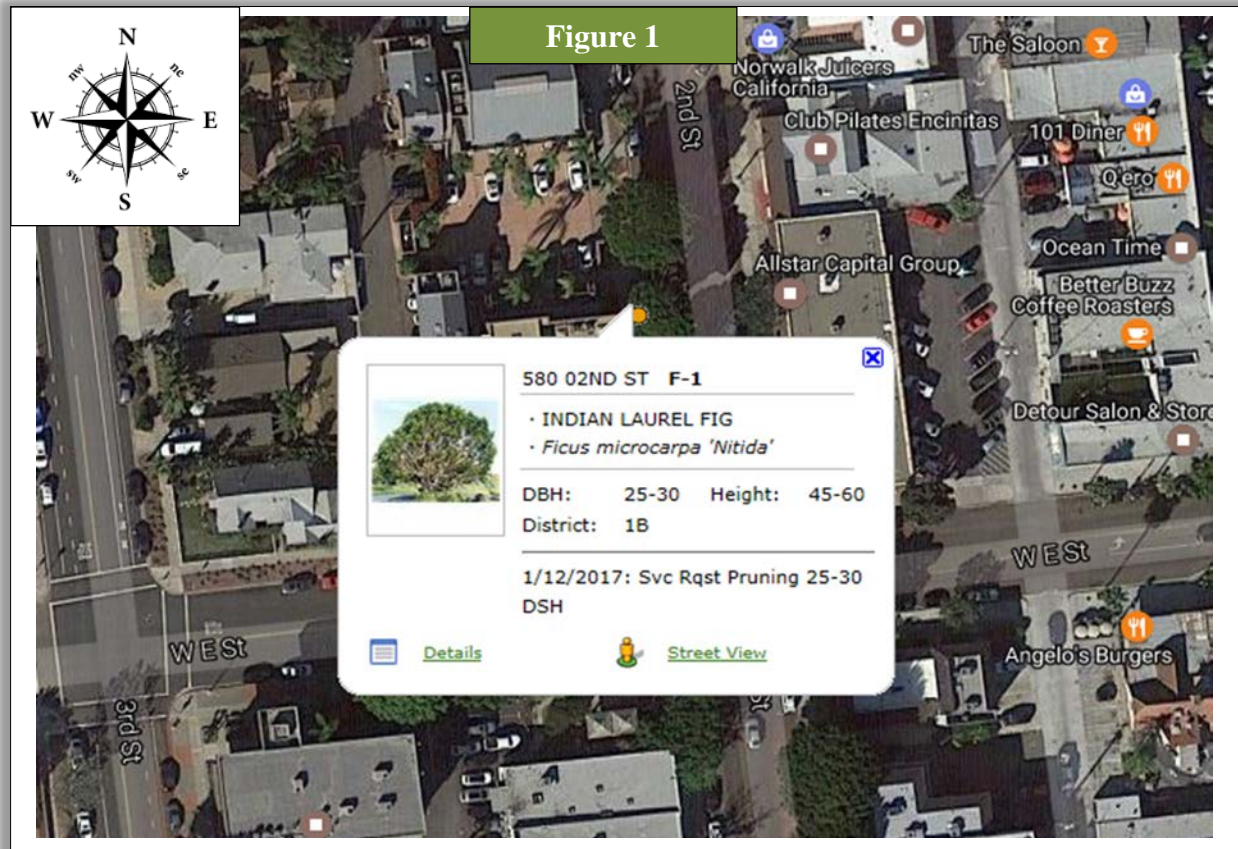
In March of 2017, West Coast Arborists, Inc., (WCA) was contacted by John Ugrob (City of Encinitas) in regard to the assessment of an Indian Laurel Fig tree (*Ficus microcarpa 'nitida'*) located near 580 2nd St. In ArborAccess (WCA's tree inventory database), the tree is inventoried as 580 02ND ST F-1 and had a Facility I.D. # of 5032ETREE (see Figure 1 below).

- The tree was growing in a 6 foot wide tree well on the west side of 2nd St. and in front of the 580 business address (see Figure 1, as well as Photo #1 in Appendix A).

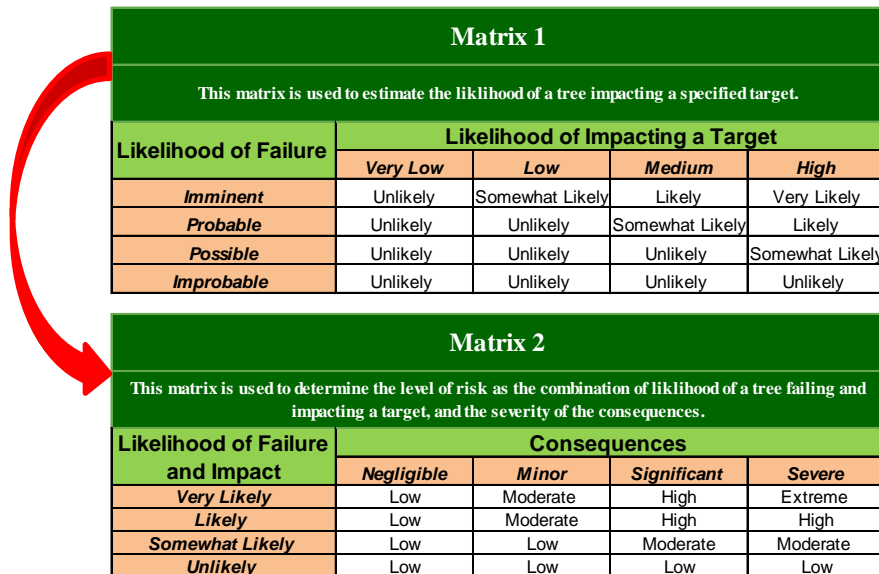
Figure 2

Data collected from the Level 2 Basic Assessment is used to derive a level of risk based on the matrices found in the *ISA Tree Risk Assessment Manual* (see **Figure 2** below). The level of risk determined (low, moderate, high, or extreme) is to be used by risk managers to help in tree management decisions. When assessing risk, the value of targets is taken into consideration in order to categorize the consequences of failure (negligible, minor, significant, or severe). The people who use and frequent the target zone are generally the most important target with buildings, structures, and cars being secondary in importance. Factors such as occupancy rate and protection factors are used to help determine the target that constitutes the highest overall Risk Rating.

The *likelihood of a failure* within the next year has been assessed as **possible** for the subject tree. The most likely and relevant failure would be uprooting of the entire tree (windthrow, root failure) because of observed root pruning, slightly unbalanced canopy, and the possibility that additional root injuries occurred when replacing the curb face. The tree did not fail throughout this recent year's abnormal winter weather conditions but failure is still possible due to these factors. This potential failure event would be most likely to occur during abnormal or extreme weather conditions.

Because of the tree's large size, *consequences* of this possible failure were assessed to be **severe** to a building or vehicle.

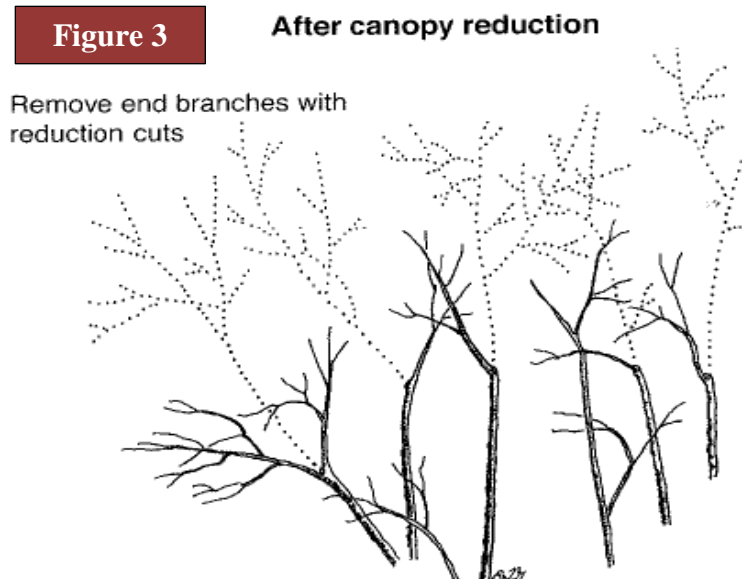
- Shown above is an example of reduction pruning techniques to achieve a canopy reduction. The diagram is from the International Society of Arboriculture “*Best Management Practices for Tree Pruning*” 2008 publication.
- If there are not suitable laterals meeting the 1/3rd size correlation, pruning other reduction cuts may only be considered under the direction of an ISA Certified Arborist. Some of these reduction pruning cuts will be done to a shoot, branch, or stem that extends nearly as far as the removed parent branch; if this is the case then additional subordination pruning cuts back to a bud or young growth may be acceptable in order to maintain a point of **apical dominance** and to achieve the reduction goal.

Risk: In order to help decrease associated risks to an overall low for the subject tree, I recommend performing an approximate 25% **canopy reduction**⁴ (see Appendix B as well as Figure 3 below). This canopy reduction will decrease the mechanical stress applied to the root system because of the increased wind penetration and reduced leverage effects from overextended growth. This work performed should be done in compliance to ANSI A300 Arboricultural Standards and will need to be applied over multiple spaced out pruning doses (taking up to five years) to minimize health impacts on the tree. This is also recommended to allow time for interior growth to further develop and broaden the options for new branches to prune back to. Pruning techniques such as **reduction pruning**, and **removal pruning cuts** should be used (not topping) to achieve this overall squattier appearance and are further explained in Appendix B.
