City of Encinitas

3.23.17 Assessment of Ficus Tree At 580 Second Street (Front-2)

MARCH 23, 2017

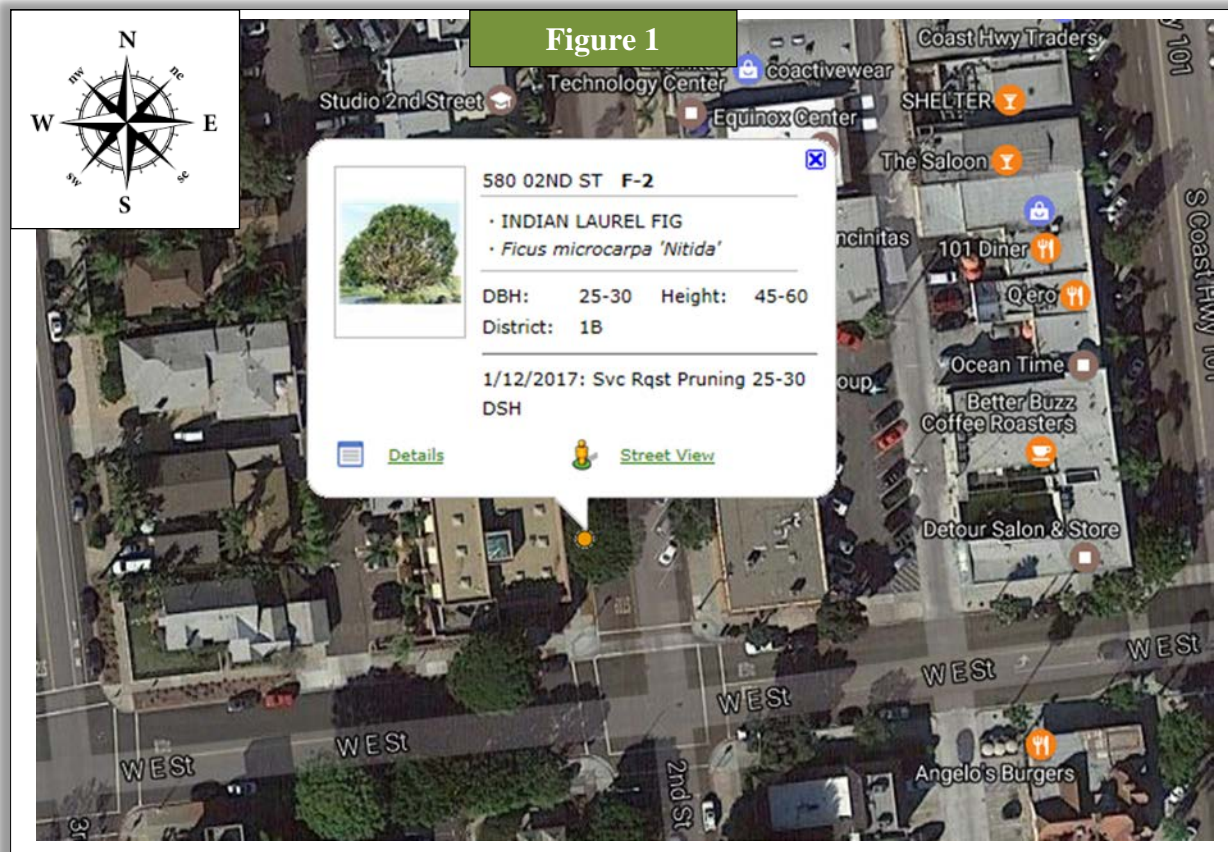
In March of 2017, West Coast Arborists, Inc., (WCA) was contacted by John Ugrob (City of Encinitas) in regard to the assessment of an Indian Laurel Fig tree (*Ficus microcarpa 'nitida'*) located near 580 2nd St. In ArborAccess (WCA's tree inventory database), the tree is inventoried as 580 02ND ST F-2 and had a Facility I.D. # of 031ETREE (see Figure 1 below).

- The tree was growing in a 6 foot wide tree well on the west side of 2nd St. and in front of the 580 business address (see Figure 1, as well as Photo #1 in Appendix A).
