City of Encinitas

4.8.17 Assessment of Ficus Tree At 580 2nd Street (Side-2)

APRIL 8, 2017

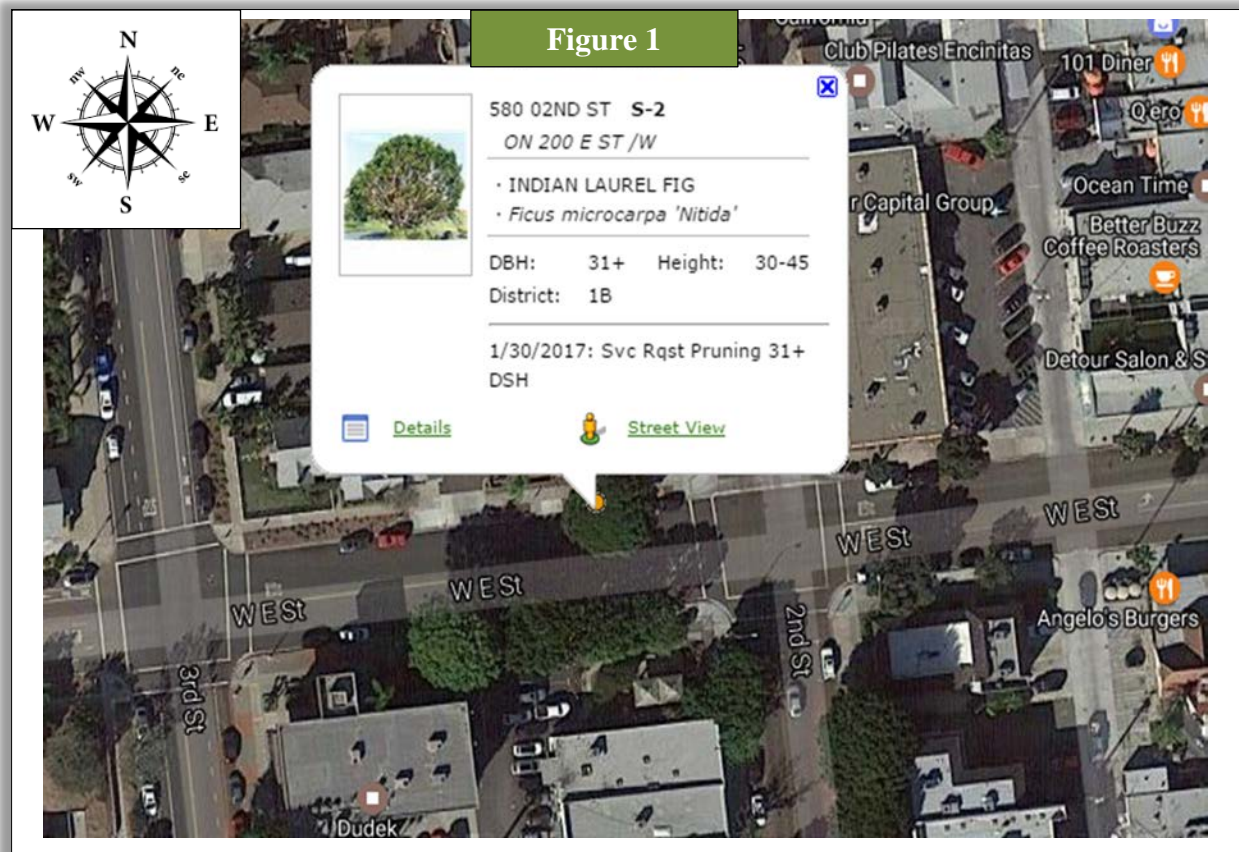
In March of 2017, West Coast Arborists, Inc., (WCA) was contacted by John Ugrob (City of Encinitas) in regard to the assessment of an Indian Laurel Fig tree (*Ficus microcarpa 'nitida'*) located near 580 2nd St. In ArborAccess (WCA's tree inventory database), the tree is inventoried as 580 2nd St S-2 and had a Facility I.D. # of 4760ETREE (see Figure 1 below).

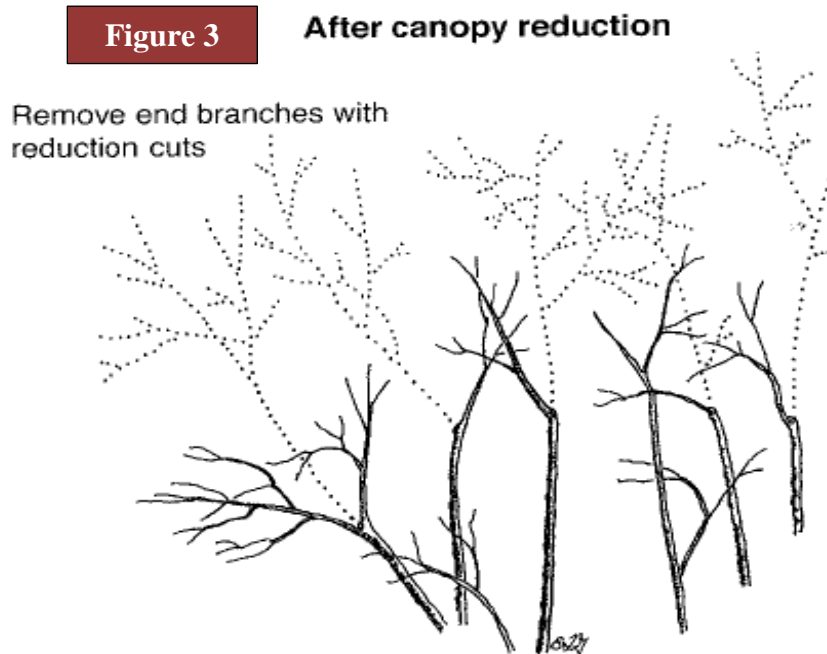
- Shown above is an example of reduction pruning techniques to achieve a canopy reduction. The diagram is from the International Society of Arboriculture “*Best Management Practices for Tree Pruning*” 2008 publication.
- If there are not suitable laterals meeting the 1/3rd size correlation, pruning other reduction cuts may only be considered under the direction of an ISA Certified Arborist. Some of these reduction pruning cuts will be done to a shoot, branch, or stem that extends nearly as far as the removed parent branch; if this is the case then additional subordination pruning cuts back to a bud or young growth may be acceptable in order to maintain a point of **apical dominance** and to achieve the reduction goal.

Risk and Mitigation – After performing a **Level 2 Basic Assessment**⁴, the subject tree was assessed to have an overall moderate risk rating. In regards to mitigating these risks, I recommend applying and maintaining an approximate 20% overall crown reduction (retaining interior growth) with the structure and canopy balance of the tree in mind (see Appendix B as well as Figure 3 below). This recommended pruning should be done in compliance to ANSI A300 Arboricultural Standards and will need to be applied over multiple spaced out pruning doses (up to five years) to minimize health impacts on the tree. This is also recommended to allow time for interior growth to further develop and broaden the options for new branches to prune back to. Pruning techniques such as **reduction pruning**, and **removal pruning cuts** should be used (not topping) to achieve this overall squattier appearance and are further explained in Appendix B. The end outcome should be a reduction of **mechanical stress** from overextended loads. A residual risk of “Low” should be achieved after implementing these recommended pruning strategies. It is with the health and safety of the community that I present these recommendations.
