City of Encinitas

4.8.17 Assessment of Ficus Tree At 610 2nd Street (Side-3)

APRIL 8, 2017

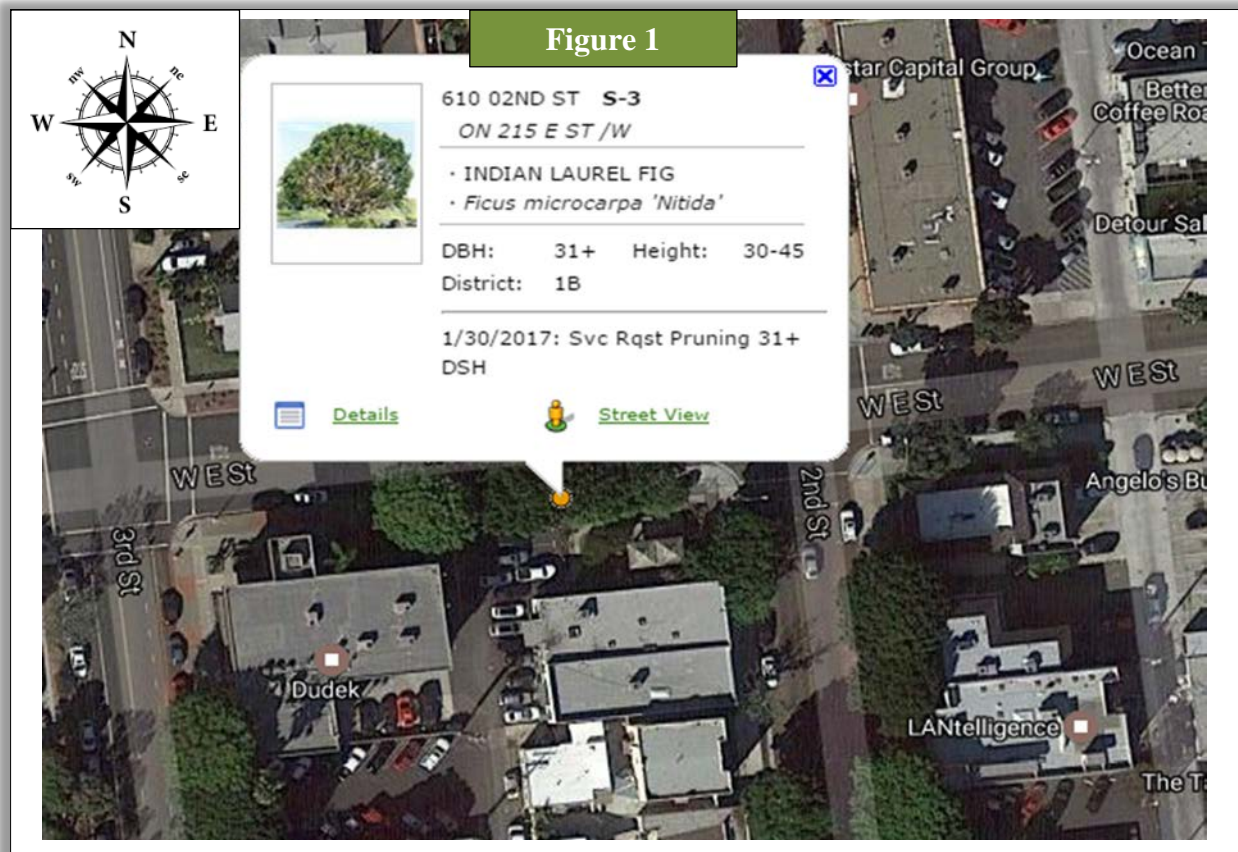
In March of 2017, West Coast Arborists, Inc., (WCA) was contacted by John Ugrob (City of Encinitas) in regard to the assessment of an Indian Laurel Fig tree (*Ficus microcarpa 'nitida'*) located near 610 2nd St. In ArborAccess (WCA's tree inventory database), the tree is inventoried as 610 2nd St. S-3 and had a Facility I.D. # of 4775ETREE (see Figure 1 below).
