# City of Encinitas

## 3.24.17 Assessment of Ficus Tree At 621 Second Street (Front-2)

MARCH 24, 2017

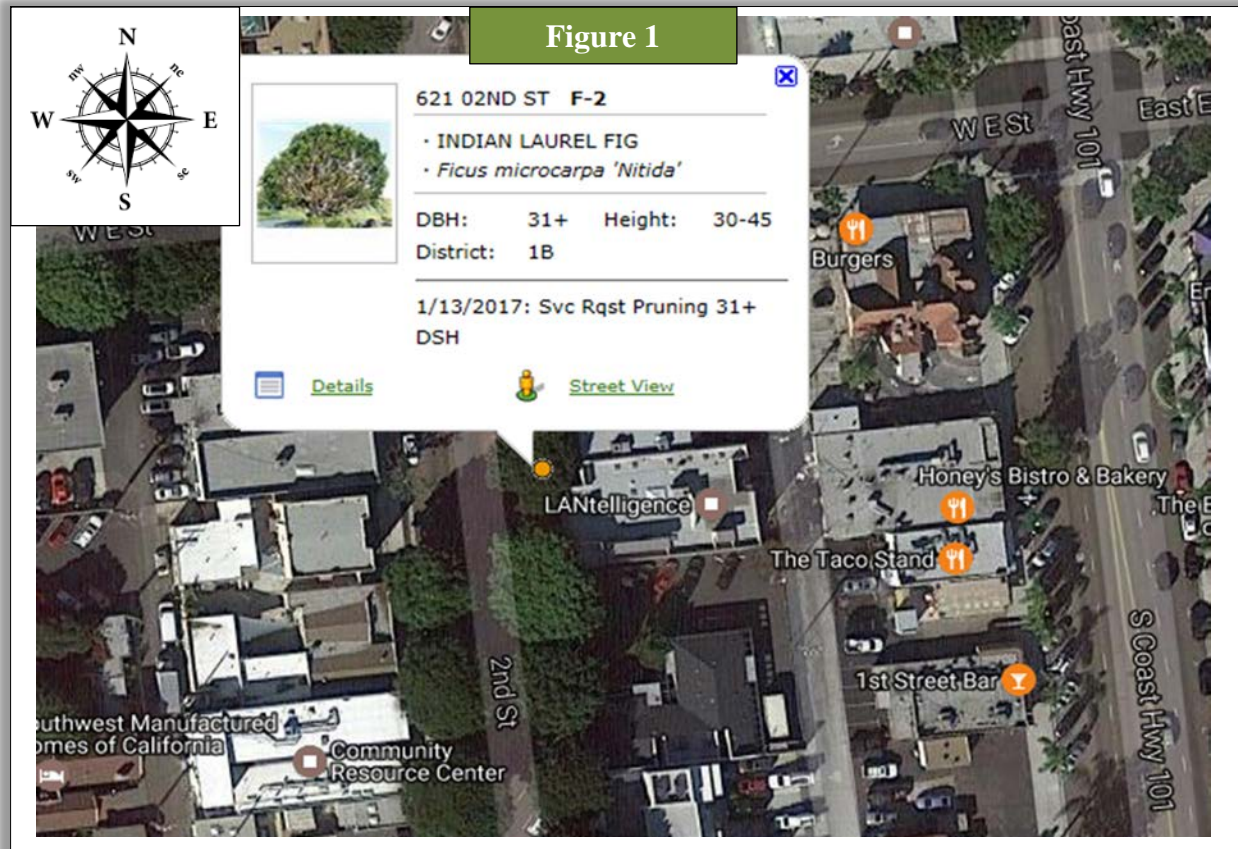
In March of 2017, West Coast Arborists, Inc., (WCA) was contacted by John Ugrob (City of Encinitas) in regard to the assessment of an Indian Laurel Fig tree (*Ficus microcarpa 'nitida'*) located near 621 2<sup>nd</sup> St. In ArborAccess (WCA's tree inventory database), the tree is inventoried as 621 02ND ST F-2 and had a Facility I.D. # of 5114ETREE (see Figure 1 below).

- The tree was growing in a 8.5 foot wide tree well on the east side of 2<sup>nd</sup> St. and in front of the 621 business address (see Figure 1, as well as Photo #1 in Appendix A).
