City of Encinitas

3.27.17 Assessment of Ficus Tree At 629 Second Street (Front-1)

Gene Bordson
Certified Arborist # WE-10777A
Qualified Applicator License# 140768
Qualified Tree Risk Assessor

MARCH 27, 2017

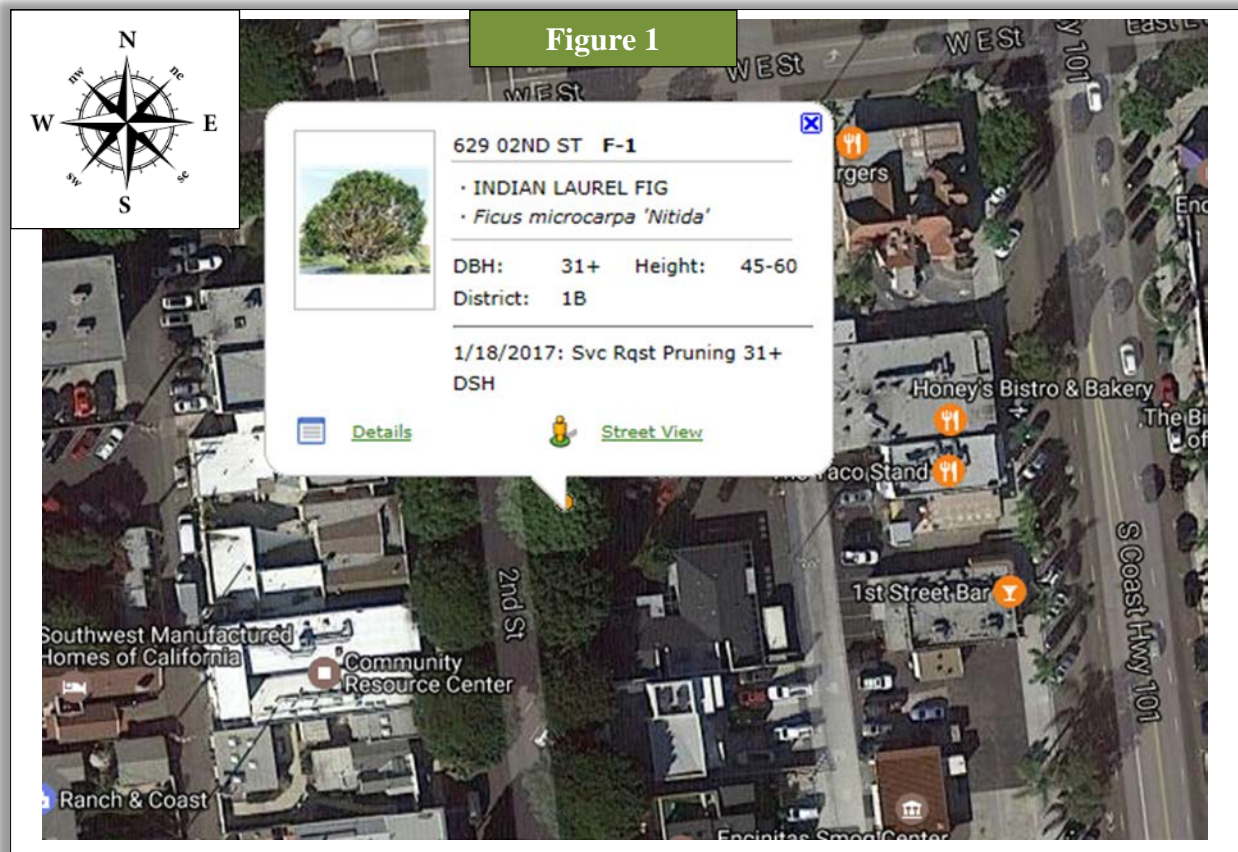
In March of 2017, West Coast Arborists, Inc., (WCA) was contacted by John Ugrob (City of Encinitas) in regard to the assessment of an Indian Laurel Fig tree (*Ficus microcarpa 'nitida'*) located near 629 2nd St. In ArborAccess (WCA's tree inventory database), the tree is inventoried as 629 02ND ST F-2 and had a Facility I.D. # of 5115ETREE (see Figure 1 below).

- The tree was growing in an 8.5 foot wide tree well on the east side of 2nd St. and in front of the 629 business address (see Figure 1, as well as Photo #1 in Appendix A).
