City of Encinitas

3.29.17 Assessment of Ficus Tree At 642 Second Street (Front-1)

Gene Bordson
Certified Arborist # WE-10777A
Qualified Applicator License# 140768
Qualified Tree Risk Assessor

MARCH 29, 2017

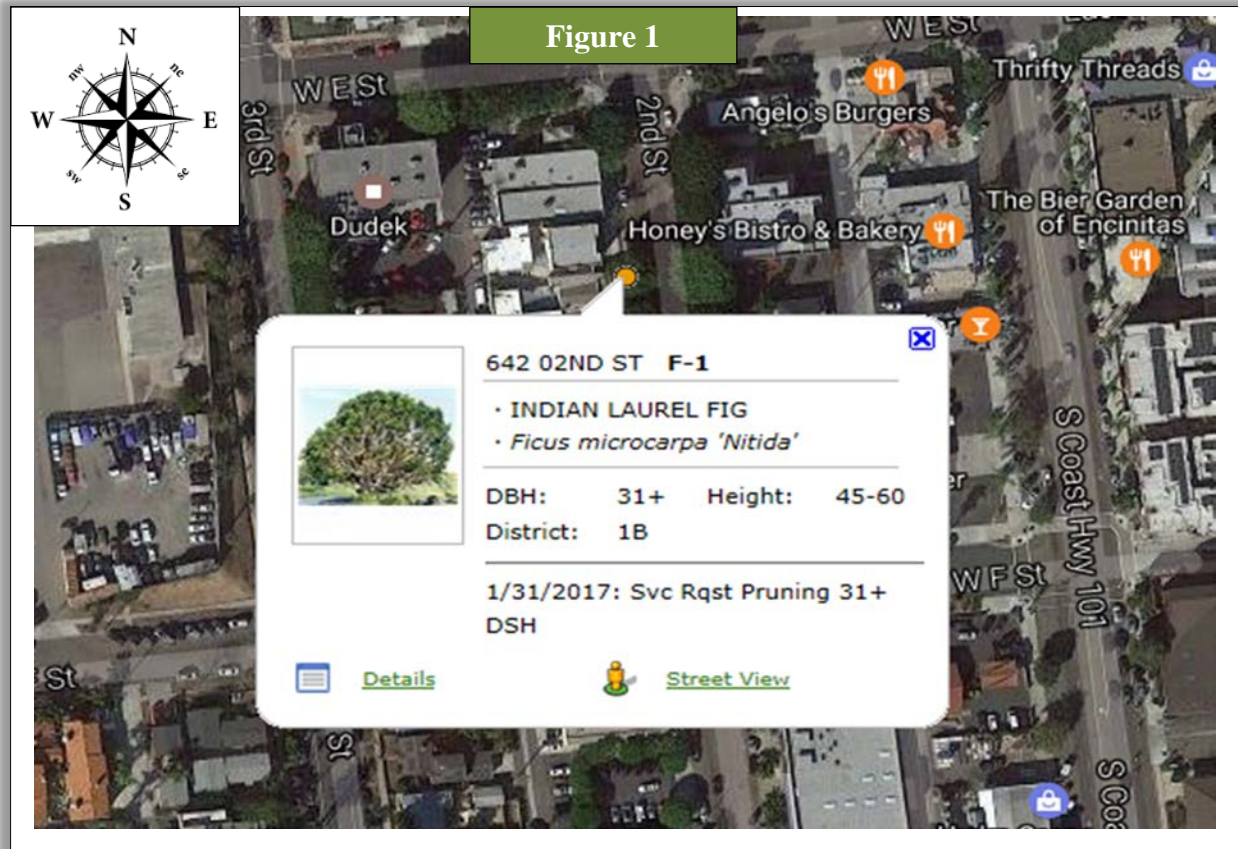
In March of 2017, West Coast Arborists, Inc., (WCA) was contacted by John Ugrob (City of Encinitas) in regard to the assessment of an Indian Laurel Fig tree (*Ficus microcarpa 'nitida'*) located in front of 642 2nd St. In ArborAccess (WCA's tree inventory database), the tree is inventoried as 642 02ND ST F-1 and had a Facility I.D. # of 5109ETREE (see Figure 1 below).
