# City of Encinitas

## 3.3.17 Assessment of Ficus Tree Near 650 Second Street

MARCH 3, 2017

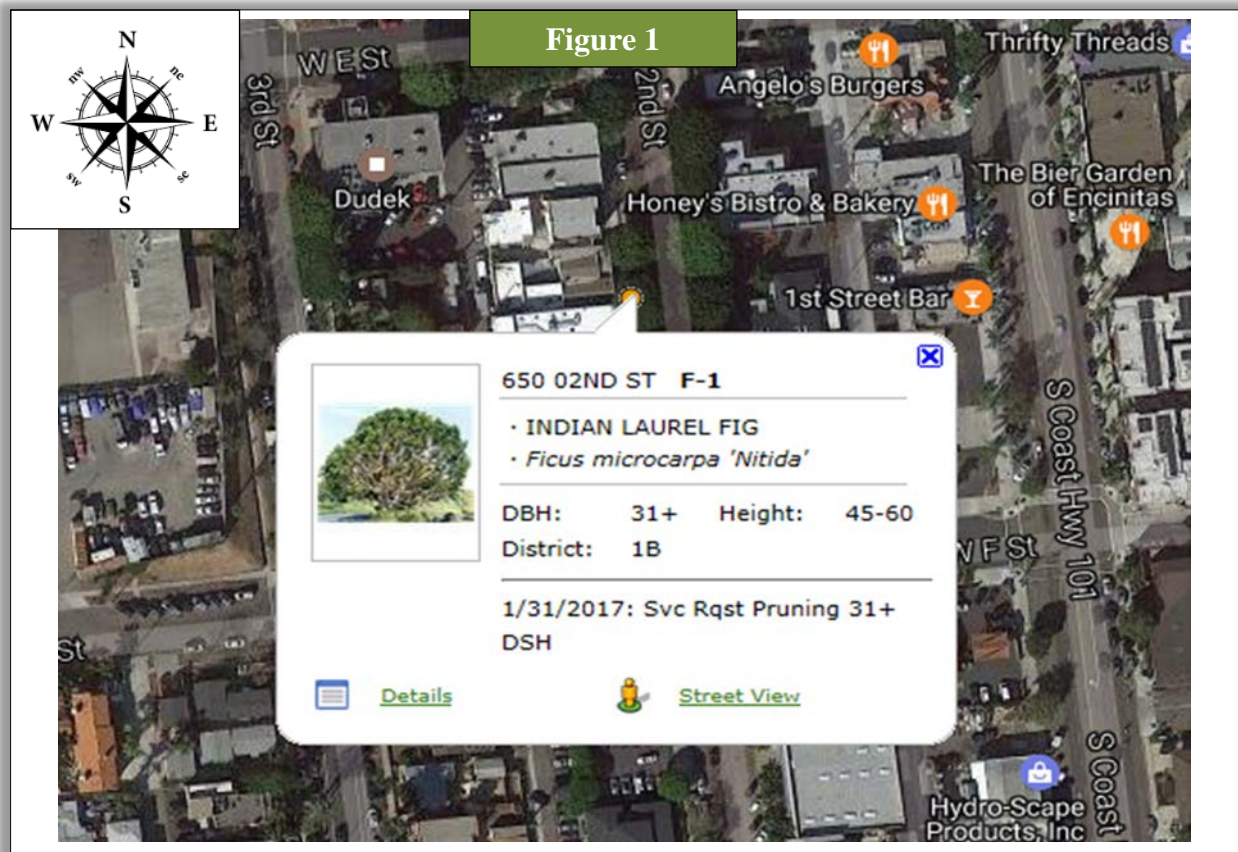
In February of 2017, West Coast Arborists, Inc., (WCA) was contacted by John Ugrob (City of Encinitas) in regard to the assessment of an Indian Laurel Fig tree (*Ficus microcarpa 'nitida'*) located on the south side of E St. near 650 2<sup>nd</sup> St. In ArborAccess (WCA's tree inventory database), the tree is inventoried as: 650 02ND ST F-1 and had a Facility I.D. # of 5108ETREE (see Figure 1 below).

- The tree was growing in a 7 foot wide parkway in front of 650 2<sup>nd</sup> St. (see Figure 1, as well as Photo #1 in Appendix A).
- Judging by the color and density of the foliage, the tree appeared to be in fair health for the species and time of year. There was a **live crown ratio** of approximately 50% which is common for street trees necessitating crown raising for vehicle clearance (see Photo #1 in Appendix A).
