# City of Encinitas

## 3.27.17 Assessment of Ficus Tree At 655 Second Street (Front-1)

MARCH 27, 2017

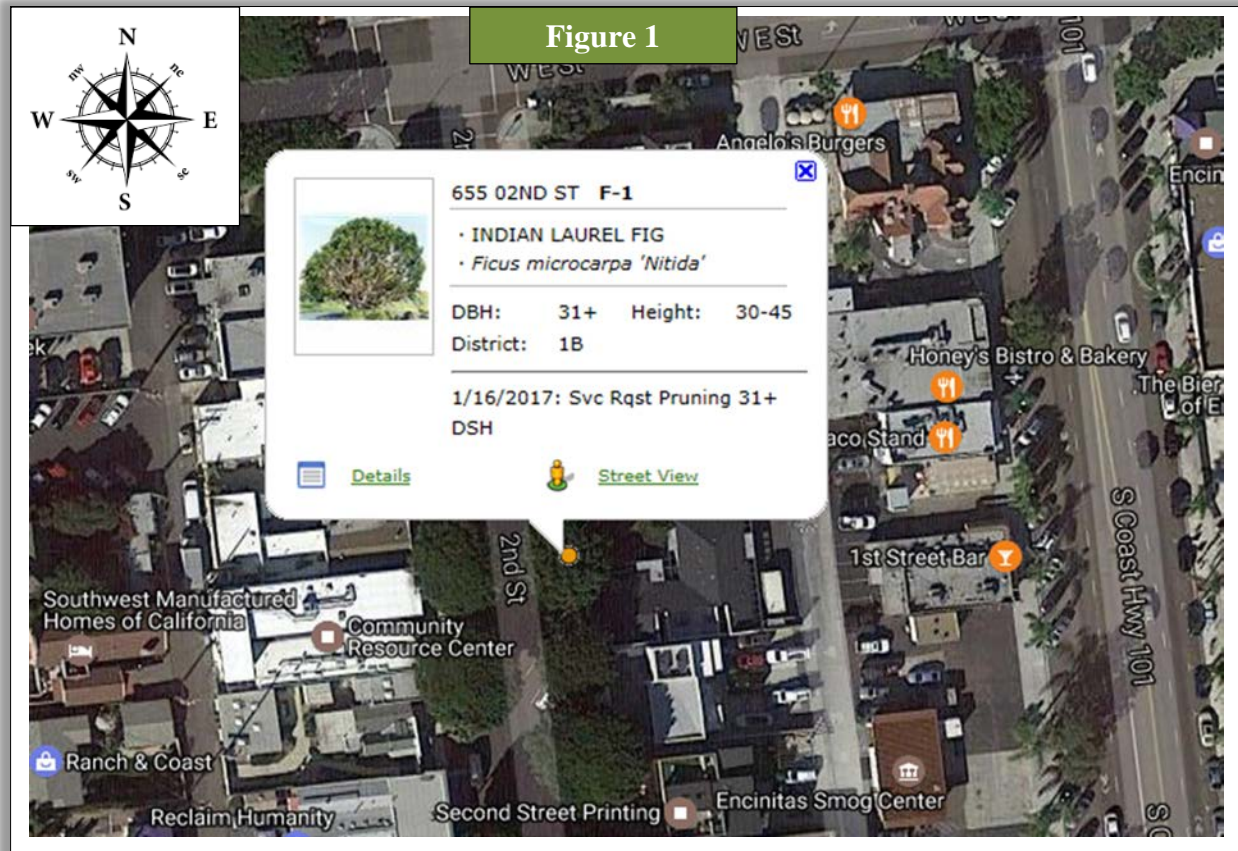
In March of 2017, West Coast Arborists, Inc., (WCA) was contacted by John Ugrob (City of Encinitas) in regard to the assessment of an Indian Laurel Fig tree (*Ficus microcarpa 'nitida'*) located near 655 2<sup>nd</sup> St. In ArborAccess (WCA's tree inventory database), the tree is inventoried as 655 02ND ST F-1 and had a Facility I.D. # of 5117ETREE (see Figure 1 below).

- The tree was growing in an 8.5 foot wide tree well on the east side of 2<sup>nd</sup> St. and in front of the 655 business address (see Figure 1, as well as Photo #1 in Appendix A).
