# City of Encinitas

## 5.23.17 Assessment of Ficus Tree At 655 2<sup>nd</sup> Street (Front-2)

Gene Bordson  
Certified Arborist # WE-10777A  
Qualified Applicator License# 140768  
Qualified Tree Risk Assessor

MAY 23, 2017

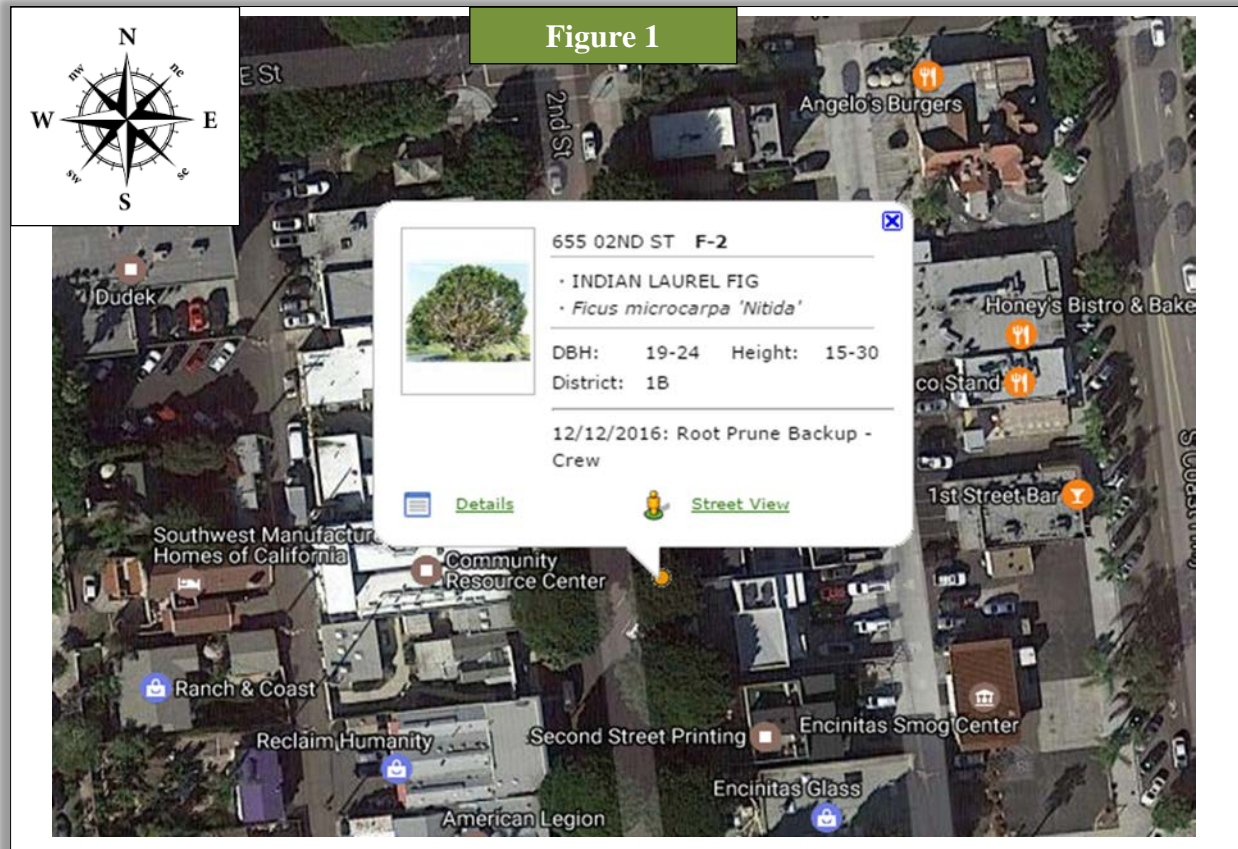
In March of 2017, West Coast Arborists, Inc., (WCA) was contacted by John Ugrob (City of Encinitas) in regard to the assessment of an Indian Laurel Fig tree (*Ficus microcarpa 'nitida'*) located near 655 2<sup>nd</sup> St. In ArborAccess (WCA's tree inventory database), the tree is inventoried as 655 2<sup>nd</sup> St. F-2 and had a Facility I.D. # of 5117ETREE (see Figure 1 below).

- The tree was located on the east side of the road between 655 and 669 2<sup>nd</sup> St. (see Photo #1 in Appendix A as well as Figure 1).
- Judging by the color and density of the foliage, the tree appeared to be in fair health for the species and time of year. The tree had a moderate **live crown ratio** of approximately 50% which is common for street trees necessitating raised crowns for vehicle and building clearance (see Photo #1 in Appendix A).

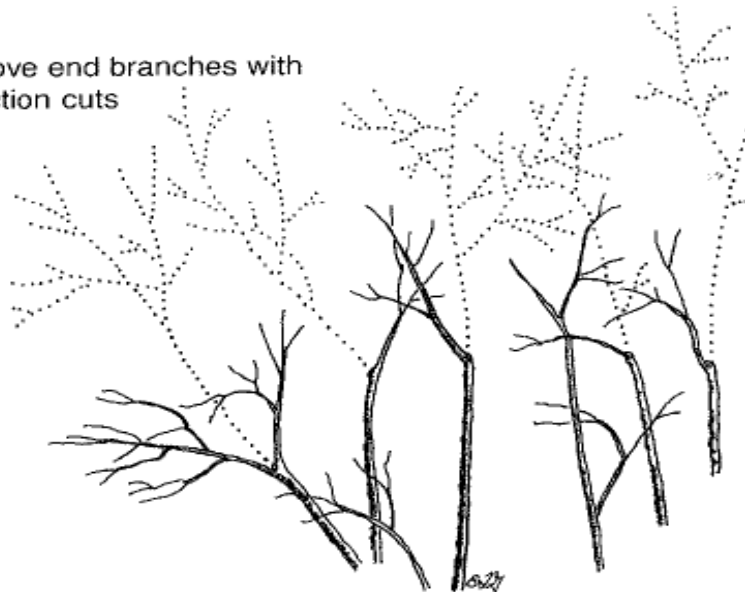
### After canopy reduction

- Shown above is an example of reduction pruning techniques to achieve a canopy reduction. The diagram is from the International Society of Arboriculture “*Best Management Practices for Tree Pruning*” 2008 publication.
- If there are not suitable laterals meeting the 1/3<sup>rd</sup> size correlation, pruning other reduction cuts may only be considered under the direction of an ISA Certified Arborist. Some of these reduction pruning cuts will be done to a shoot, branch, or stem that extends nearly as far as the removed parent branch; if this is the case then additional subordination pruning cuts back to a bud or young growth may be acceptable in order to maintain a point of **apical dominance** and to achieve the reduction goal.

After performing a **Level 2 Basic Assessment**<sup>4</sup>, the subject tree was assessed to currently have an overall moderate risk rating. In regards to mitigating these risks, I recommend continuing to apply the crown reduction pruning dose of approximately 6% per year as previously recommended in the report from 10/21/2016. At this point in time, an approximate 10 foot overall crown reduction (while retaining interior growth) still remains to achieve the overall recommended goal (see Appendix B and Figure 3 below). This recommended pruning should be done in compliance to ANSI A300 Arboricultural Standards and will need to be applied over multiple spaced out pruning doses to minimize health impacts on the tree. This is also recommended to allow time for interior growth to further develop and broaden the options for new branches to prune back to.

Pruning techniques such as **reduction pruning**, and **removal pruning cuts** should be used (not topping) to achieve this overall squattier appearance and are further explained in Appendix B. The end outcome should be a reduction of **mechanical stress** from overextended loads. A residual risk of “Low” should be achieved after completing these recommended pruning strategies. It is with the health and safety of the community that I present these recommendations.
