City of Encinitas

5.23.17 Assessment of Ficus Tree At 669 2nd Street (Front-1)

MAY 23, 2017

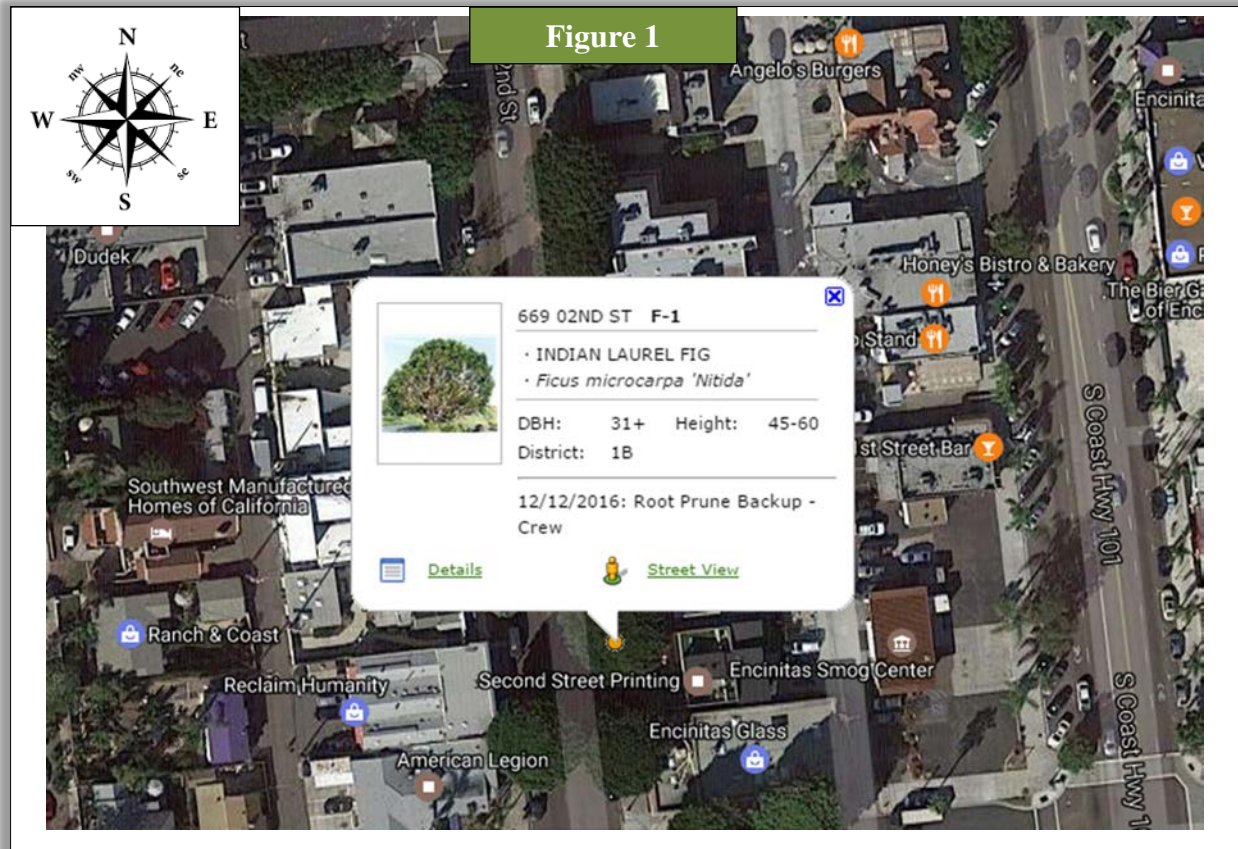
In March of 2017, West Coast Arborists, Inc., (WCA) was contacted by John Ugrob (City of Encinitas) in regard to the assessment of an Indian Laurel Fig tree (*Ficus microcarpa 'nitida'*) located near 669 2nd St. In ArborAccess (WCA's tree inventory database), the tree is inventoried as 669 2nd St. F-1 and had a Facility I.D. # of 5118ETREE (see Figure 1 below).

- The tree was located on the east side of the road in front of 669 2nd St. (see Photo #1 in Appendix A as well as Figure 1).
- Judging by the color and density of the foliage, the tree appeared to be in fair health for the species and time of year. The tree had a moderate **live crown ratio** of approximately 50% which is common for street trees necessitating raised crowns for vehicle and building clearance (see Photo #1 in Appendix A).
