City of Encinitas

4.10.17 Assessment of Ficus Tree At 687 2nd Street (Side-1)

Gene Bordson
Certified Arborist # WE-10777A
Qualified Applicator License# 140768
Qualified Tree Risk Assessor

APRIL 10, 2017

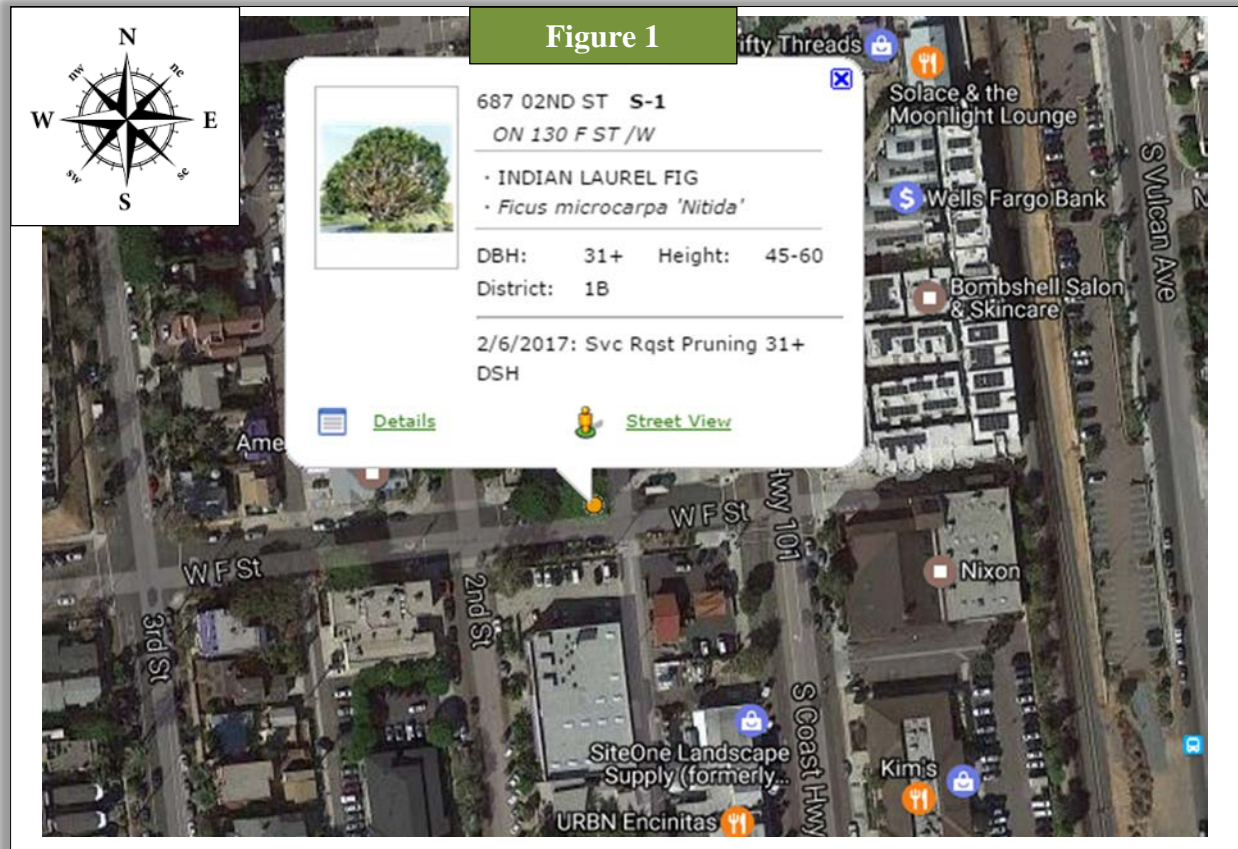
In March of 2017, West Coast Arborists, Inc., (WCA) was contacted by John Ugrob (City of Encinitas) in regard to the assessment of an Indian Laurel Fig tree (*Ficus microcarpa 'nitida'*) located near 687 2nd St. In ArborAccess (WCA's tree inventory database), the tree is inventoried as 687 2nd St. S-1 and had a Facility I.D. # of 5695ETREE (see Figure 1 below).
