City of Encinitas

3.30.17 Assessment of Ficus Tree At 965 Second Street (Front-2)

Gene Bordson
Certified Arborist # WE-10777A
Qualified Applicator License# 140768
Qualified Tree Risk Assessor

MARCH 30, 2017

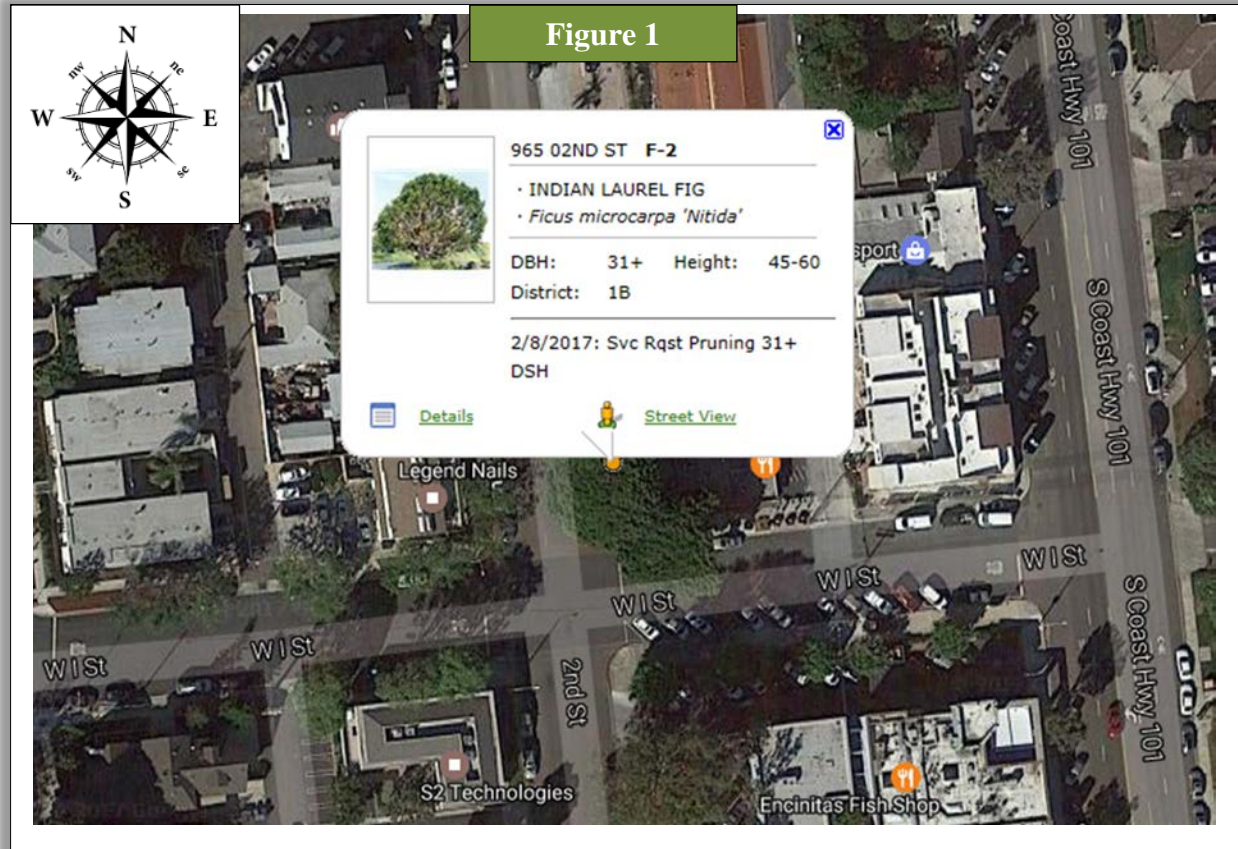
In March of 2017, West Coast Arborists, Inc., (WCA) was contacted by John Ugrob (City of Encinitas) in regard to the assessment of an Indian Laurel Fig tree (*Ficus microcarpa 'nitida'*) located in front of 965 2nd St. In ArborAccess (WCA's tree inventory database), the tree is inventoried as 965 02ND ST F-2 and had a Facility I.D. # of 25713ETREE (see Figure 1 below).

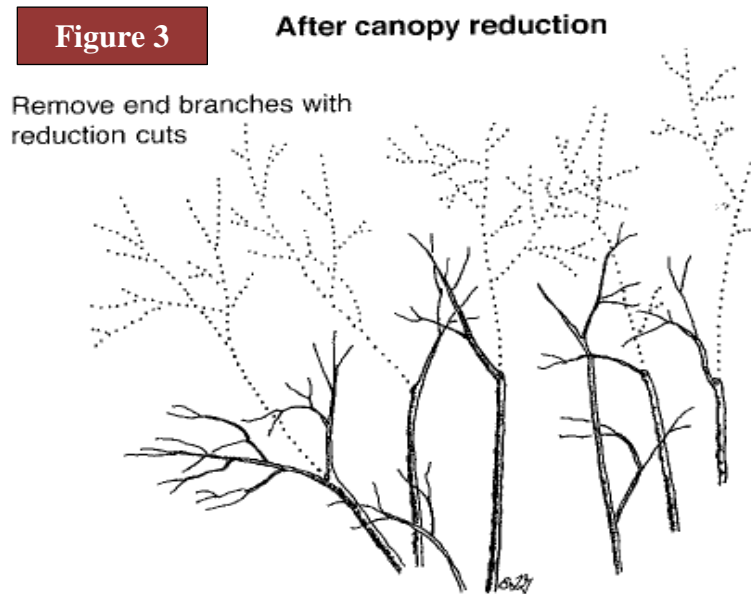
- Shown above is an example of reduction pruning techniques to achieve a canopy reduction. The diagram is from the International Society of Arboriculture “*Best Management Practices for Tree Pruning*” 2008 publication.
- If there are not suitable laterals meeting the 1/3rd size correlation, pruning other reduction cuts may only be considered under the direction of an ISA Certified Arborist. Some of these reduction pruning cuts will be done to a shoot, branch, or stem that extends nearly as far as the removed parent branch; if this is the case then additional subordination pruning cuts back to a bud or young growth may be acceptable in order to maintain a point of **apical dominance** and to achieve the reduction goal.

Risk: In order to help decrease associated risks to an overall moderate to a low for the subject tree, I recommend performing an approximate 25% **crown reduction**⁴ (see Appendix B as well as Figure 3 below). This crown reduction will decrease the mechanical stress applied to the root system because of the increased wind penetration and reduced leverage effects from overextended growth. The work performed should be done in compliance to ANSI A300 Arboricultural Standards and will need to be applied over multiple spaced out pruning doses (taking up to 5 years) to minimize health impacts on the tree. This is also recommended to allow time for interior growth to further develop and broaden the options for new branches to prune back to. Pruning techniques such as **reduction pruning**, and **removal pruning cuts** should be used (not topping) to achieve this overall squattier appearance and are further explained in Appendix B. It is with the health and safety of the community in mind that I present these recommendations.
