# City of Encinitas

## 3.22.17 Assessment of Ficus Tree Near 501 Second Street

MARCH 22, 2017

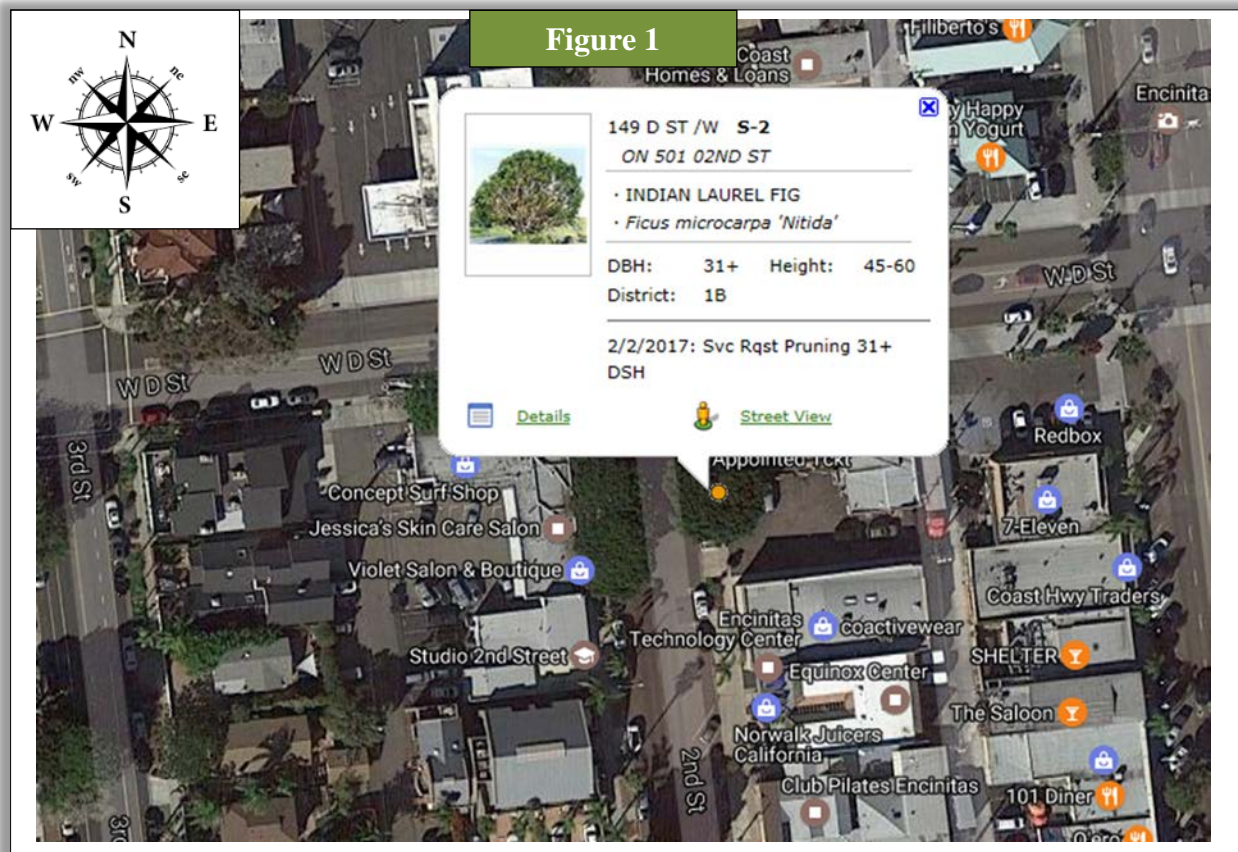
In March of 2017, West Coast Arborists, Inc., (WCA) was contacted by John Ugrob (City of Encinitas) in regard to the assessment of an Indian Laurel Fig tree (*Ficus microcarpa 'nitida'*) located near 501 2<sup>nd</sup> St. In ArborAccess (WCA's tree inventory database), the tree is inventoried as 149 D ST/ W S-2 on 501 02<sup>nd</sup> St and had a Facility I.D. # of 5025ETREE (see Figure 1 below).

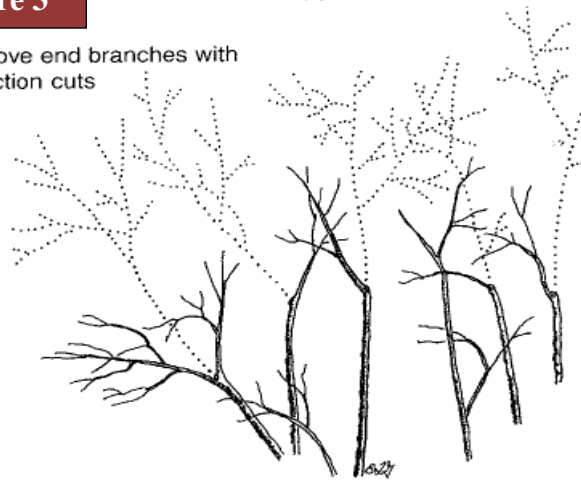
- Shown above is an example of reduction pruning techniques to achieve a canopy reduction. The diagram is from the International Society of Arboriculture “*Best Management Practices for Tree Pruning*” 2008 publication.
- If there are not suitable laterals meeting the 1/3<sup>rd</sup> size correlation, pruning other reduction cuts may only be considered under the direction of an ISA Certified Arborist. Some of these reduction pruning cuts will be done to a shoot, branch, or stem that extends nearly as far as the removed parent branch; if this is the case then additional subordination pruning cuts back to a bud or young growth may be acceptable in order to maintain a point of **apical dominance** and to achieve the reduction goal.

**Risk and Mitigation** – After performing a **Level 2 Basic Assessment**<sup>4</sup>, the subject tree was assessed to have an overall moderate risk rating. In regards to mitigating risks, I recommend applying an approximate 25% overall crown reduction with the structure and canopy balance of the tree in mind (see Appendix B and Figure 3 below). This recommended pruning should be done in compliance to ANSI A300 Arboricultural Standards and will need to be applied over multiple spaced out yearly pruning doses (up to five years) to minimize health impacts on the tree. This is also done to allow time for interior growth to further develop and broaden the options for new branches to prune back to. Pruning techniques such as **reduction pruning**, and **removal pruning cuts** should be used (not topping) to achieve this overall squattier appearance and are further explained in Appendix B. The end outcome should be a reduction of **mechanical stress** from overextended loads and an improvement in wind penetration. A residual risk of “Low” should be achieved after implementing these recommended pruning strategies.
