City of Encinitas

4.7.17 Assessment of Ficus Tree At 215 D Street (Front-1)

APRIL 7, 2017

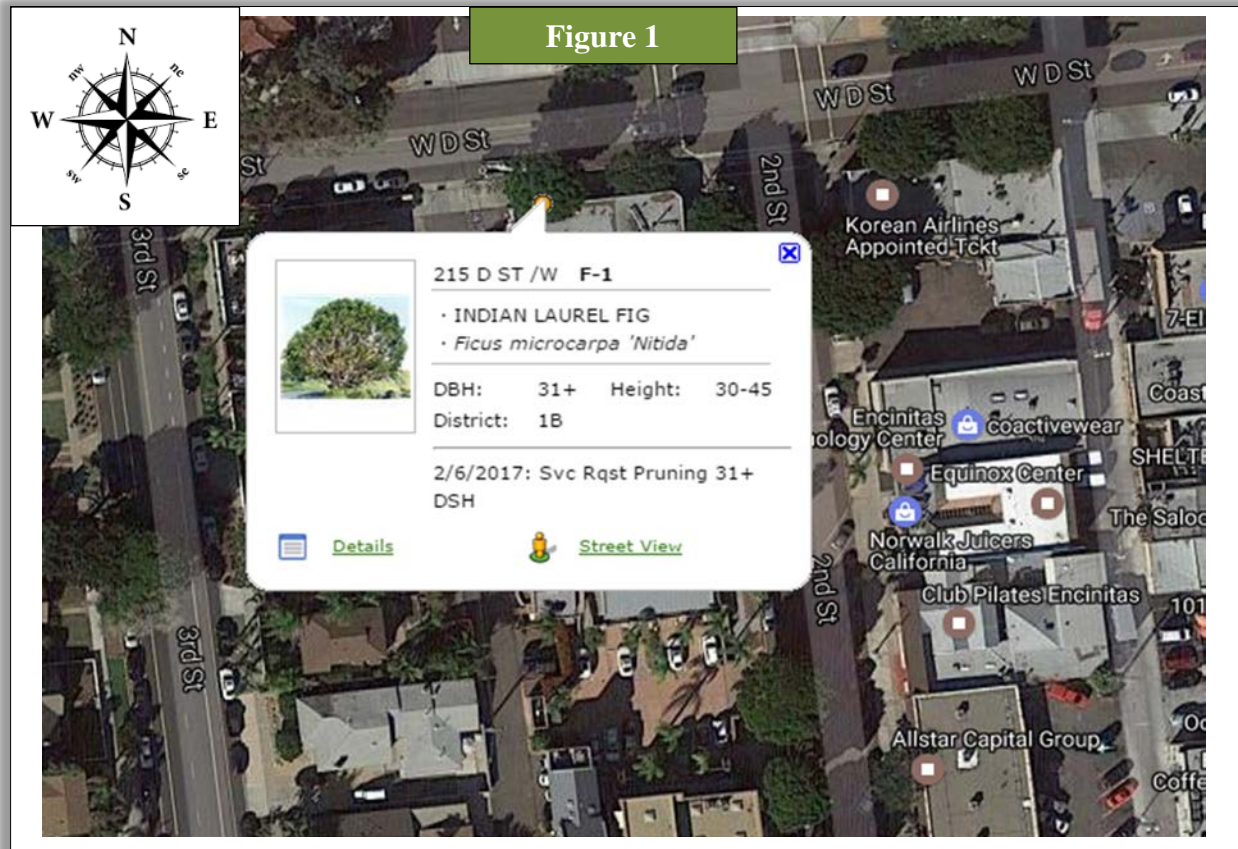
In March of 2017, West Coast Arborists, Inc., (WCA) was contacted by John Ugrob (City of Encinitas) in regard to the assessment of an Indian Laurel Fig tree (*Ficus microcarpa 'nitida'*) located near 215 D St. In ArborAccess (WCA's tree inventory database), the tree is inventoried as 215 D St /W F-1 and had a Facility I.D. # of 4852ETREE (see Figure 1 below).
