City of Encinitas

3.3.17 Assessment of Ficus Tree Near 700 F Street

Gene Bordson
Certified Arborist # WE-10777A
Qualified Applicator License# 140768
Qualified Tree Risk Assessor

MARCH 3, 2017

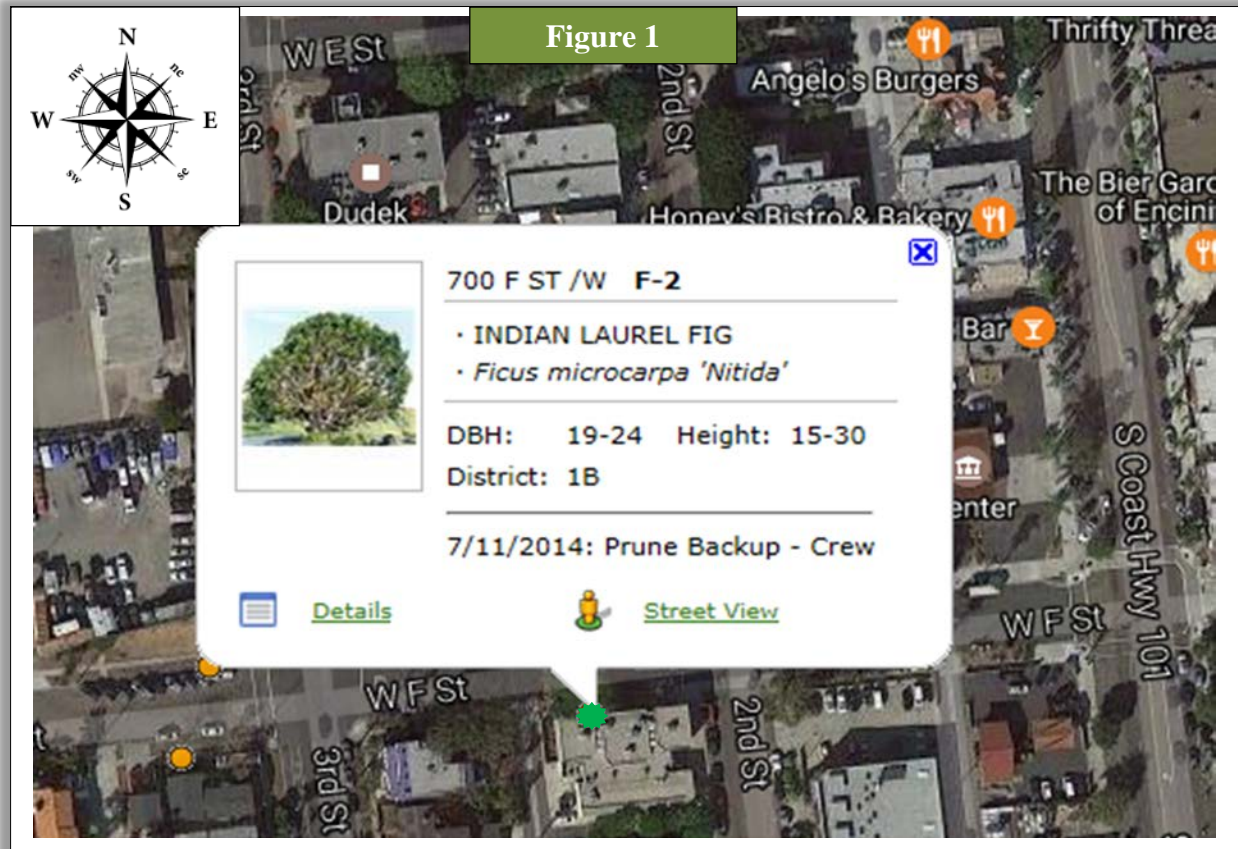
In February of 2017, West Coast Arborists, Inc., (WCA) was contacted by John Ugrob (City of Encinitas) in regard to the assessment of an Indian Laurel Fig tree (*Ficus microcarpa 'nitida'*) located near 700 F St. In ArborAccess (WCA's tree inventory database), the tree is inventoried as: 700 F ST/ W F-2 and had a Facility I.D. # of 5688ETREE (see Figure 1 below).

- The tree was growing in an 8 foot wide parkway on the south side F St. near the 700 building (see Figure 1, as well as Photo #1 in Appendix A).
- Judging by the color and density of the foliage, the tree appeared to be in fair health for the species and time of year (see Photo #1 in Appendix A).
