# City of Encinitas

## 4.20.17 Assessment of Ficus Tree At 120 I St. / W (Front-2)

Gene Bordson  
Certified Arborist # WE-10777A  
Qualified Applicator License# 140768  
Qualified Tree Risk Assessor

APRIL 20, 2017

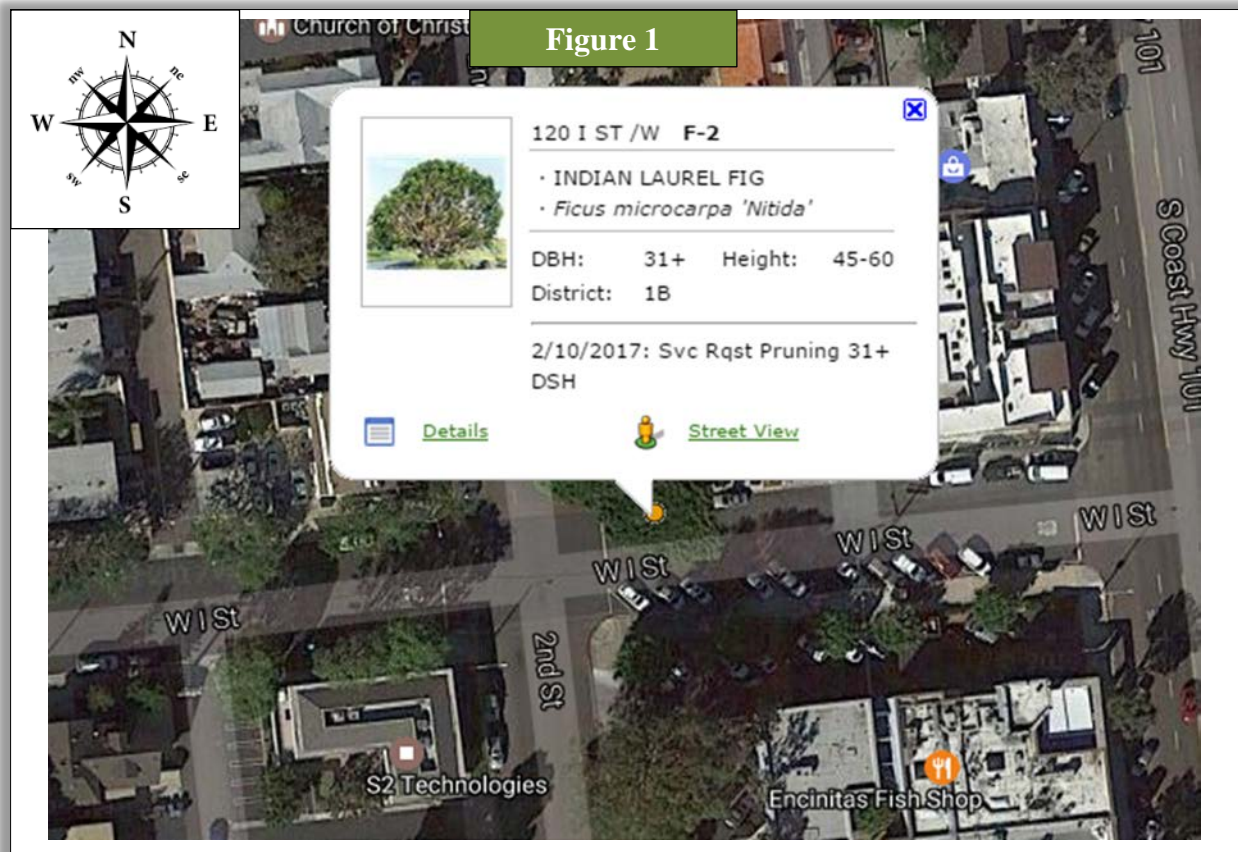
In March of 2017, West Coast Arborists, Inc., (WCA) was contacted by John Ugrob (City of Encinitas) in regard to the assessment of an Indian Laurel Fig tree (*Ficus microcarpa 'nitida'*) located near 120 I St. In ArborAccess (WCA's tree inventory database), the tree is inventoried as 120 I St. /W F-2 and had a Facility I.D. # of 5924ETREE (see Figure 1 below).

- The tree was growing in a tree well on the north side of I St. (see Figure 1 and Photo #1 in Appendix A).
- Judging by the color and density of the foliage, the tree appeared to be in fair health for the species and time of year. There was a lack of foliage on the east side of the tree likely related to shading out from an adjacent tree which had been removed. The tree had a moderate **live crown ratio** of approximately 50% which is common for street trees necessitating raised crowns for vehicle and building clearance (see Photo #1 in Appendix A).
