City of Encinitas

4.14.17 Assessment of Ficus Tree At 222 J Street /W (Front-2)

APRIL 14, 2017

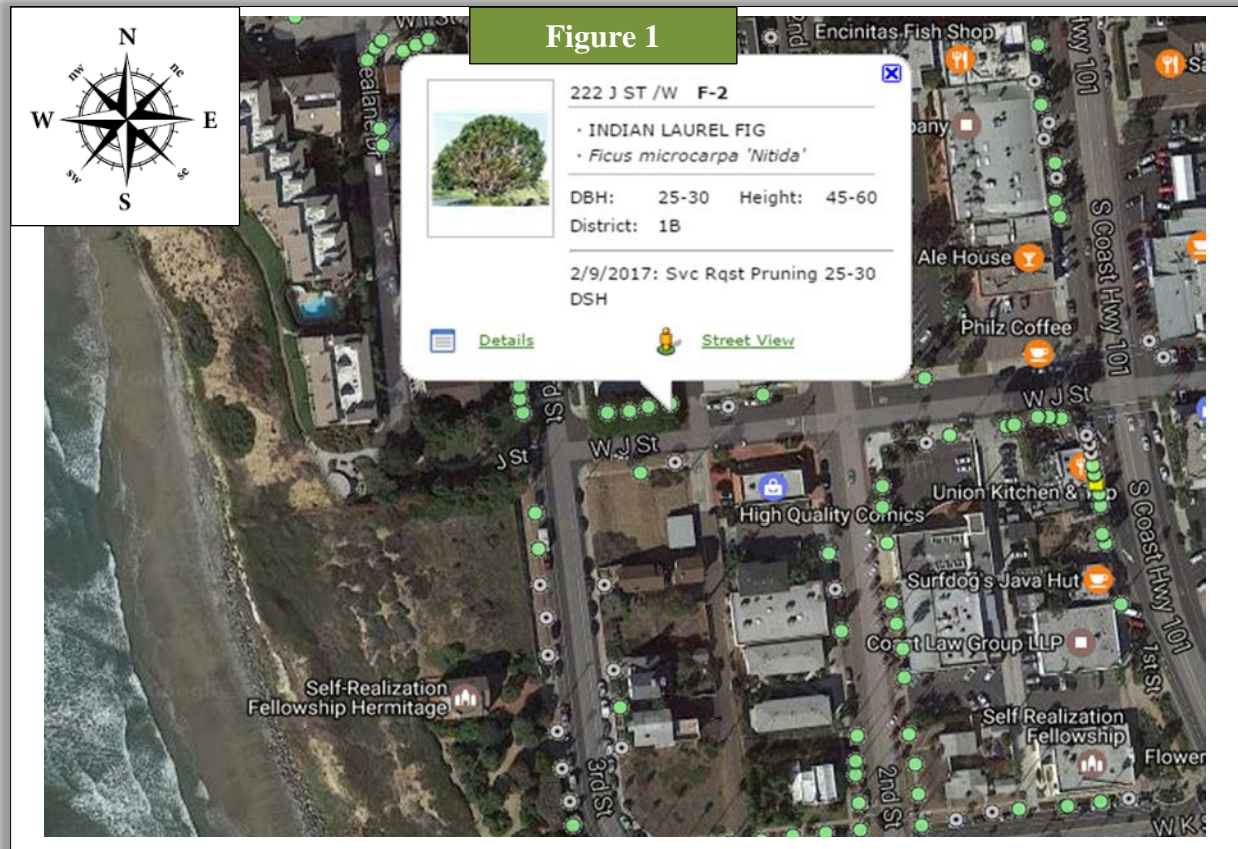
In March of 2017, West Coast Arborists, Inc., (WCA) was contacted by John Ugrob (City of Encinitas) in regard to the assessment of an Indian Laurel Fig tree (*Ficus microcarpa 'nitida'*) located near 222 J St. In ArborAccess (WCA's tree inventory database), the tree is inventoried as 222 J St. /W F-2 and had a Facility I.D. # of 5903ETREE (see Figure 1 below).

- The tree was growing in a parkway on the north side of J St. (see Figure 1 and Photo #1 in Appendix A).
- Judging by the color and density of the foliage, the tree appeared to be in fair health for the species and time of year. The tree had a moderate **live crown ratio** of approximately 50% which is common for street trees necessitating raised crowns for vehicle and building clearance (see Photo #1 in Appendix A).
