**STORM WATER
MANAGEMENT
INVESTIGATION**

**TORREY CREST
1220-1240 MELBA ROAD AND
1190 ISLAND VIEW LANE
ENCINITAS, CALIFORNIA**

GEOCON
INCORPORATED

**JANUARY 8, 2021
REVISED MARCH 21, 2021
PROJECT NO. G2438-52-01**

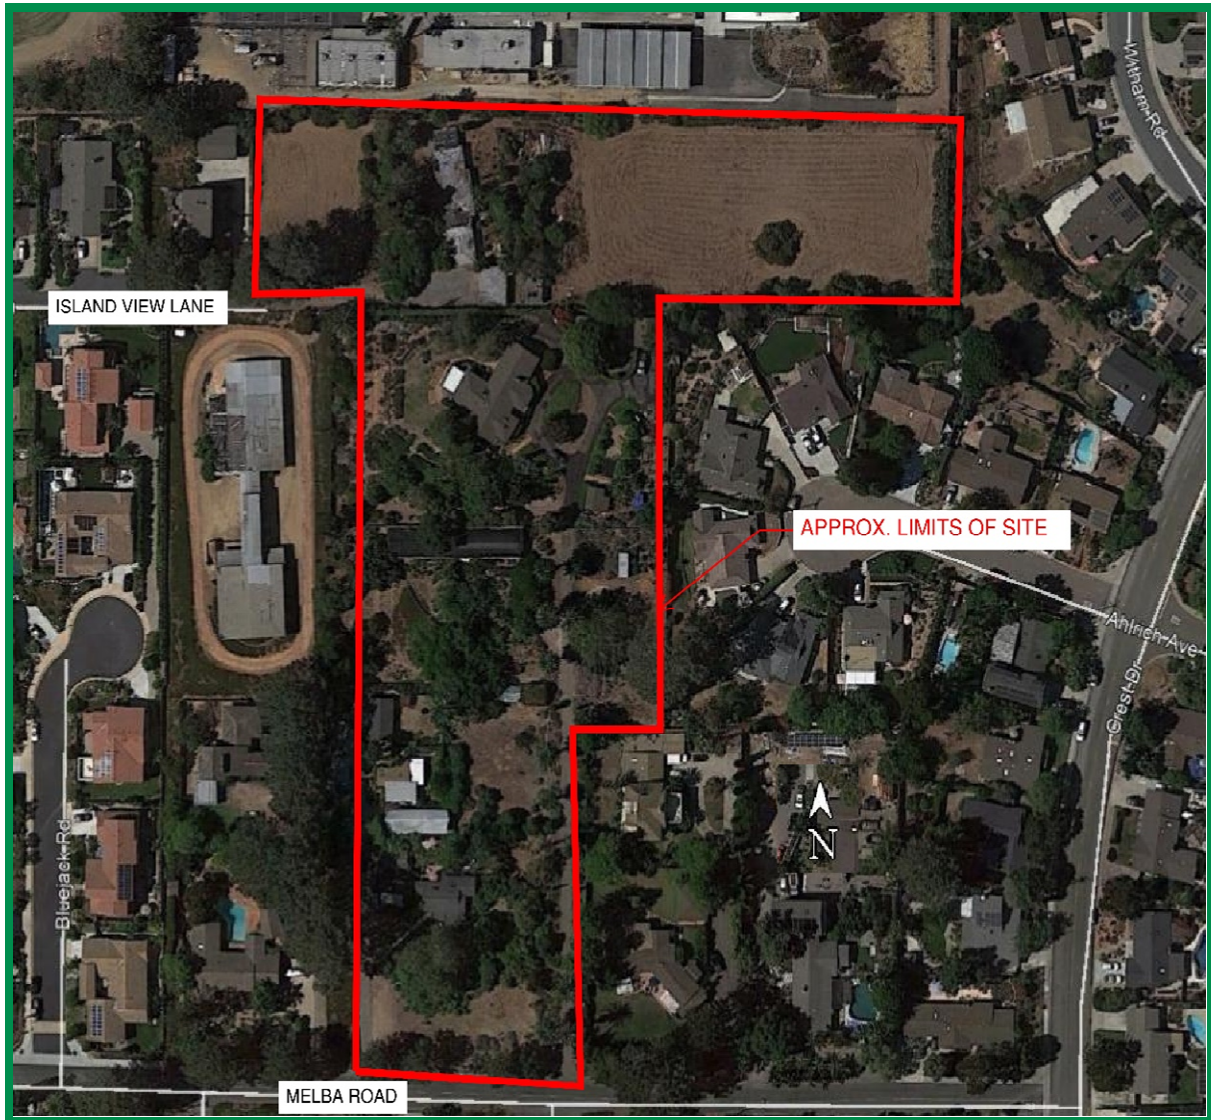
Existing Site Map

The property is located north of Melba Road and east of the Island View Lane terminus in the City of Encinitas, California. The subject project site is occupied by four single-family residences with accompanied ancillary structures, utilities, landscaping and driveways. The property is accessed by two driveways from Melba Road and a driveway from Island View Lane. The topography is relatively flat to gently sloping at an elevation of about 370 to 400 feet above mean sea level (MSL). The Existing Site Plan shows the current site conditions.

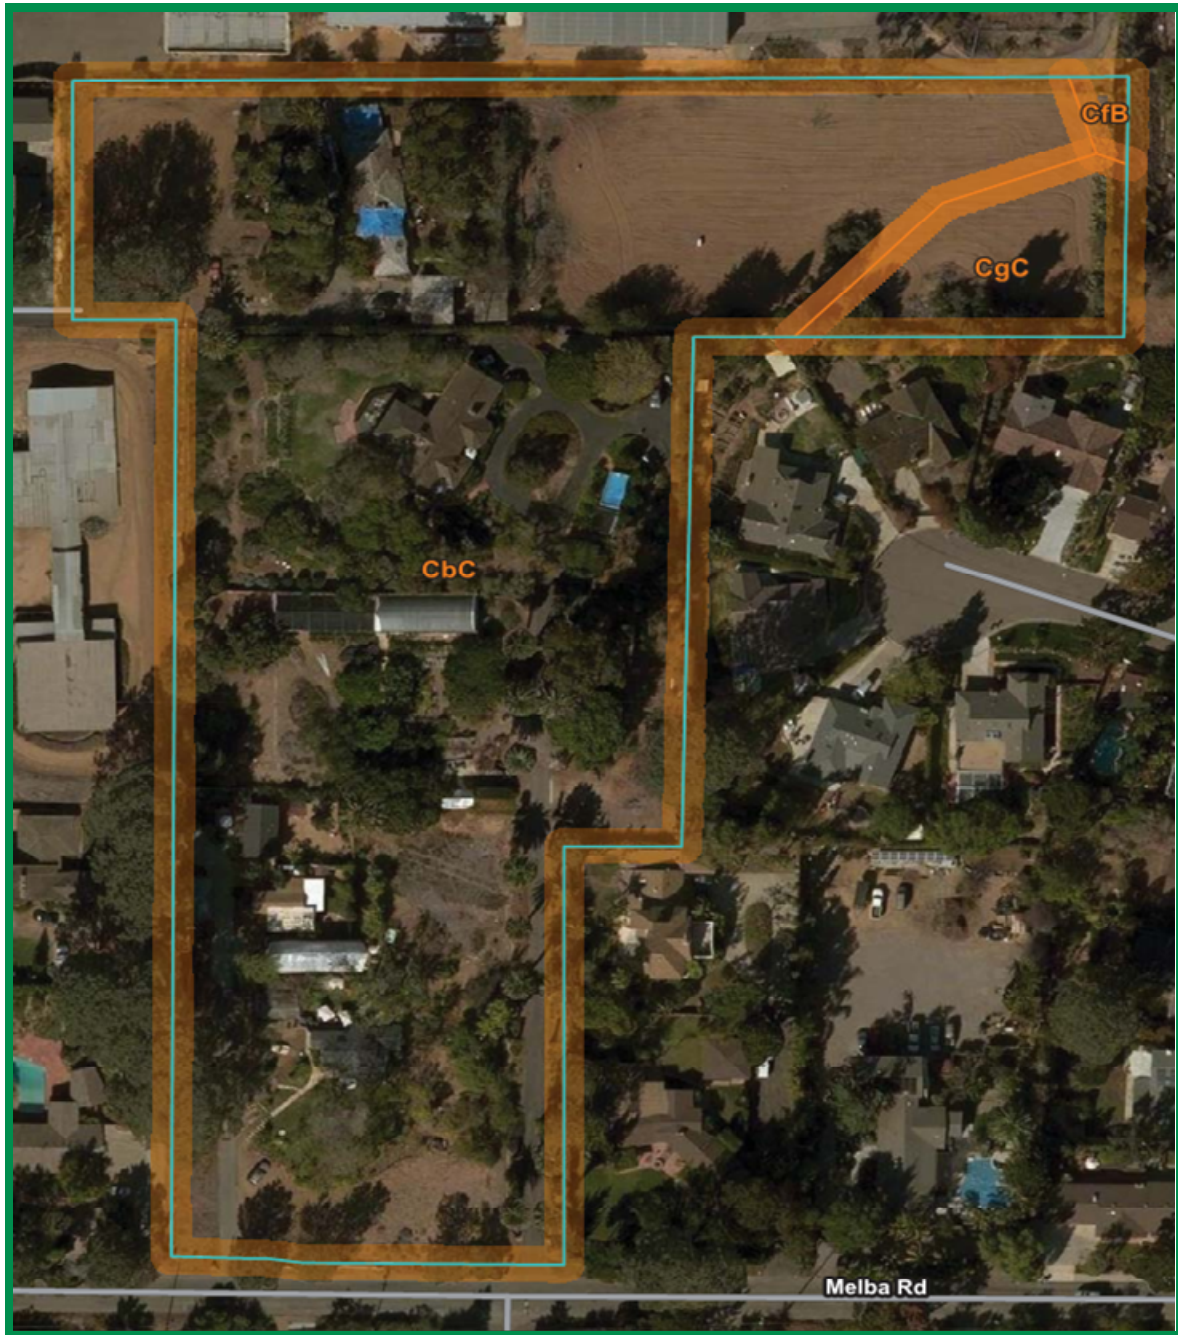
The property is surficially underlain by Very Old Paralic Deposits with very slow infiltration rates and should be classified as Soil Group D. The Hydrologic Soil Group Map presents output from the USDA website showing the limits of the soil units. Table 2 presents the information from the USDA website for the subject property.
